CHESTER CONGREGATIONAL CHURCH

PHOTO REPORT MARCH\APRIL 2018

By Arron Sturgis on March 26, 2018

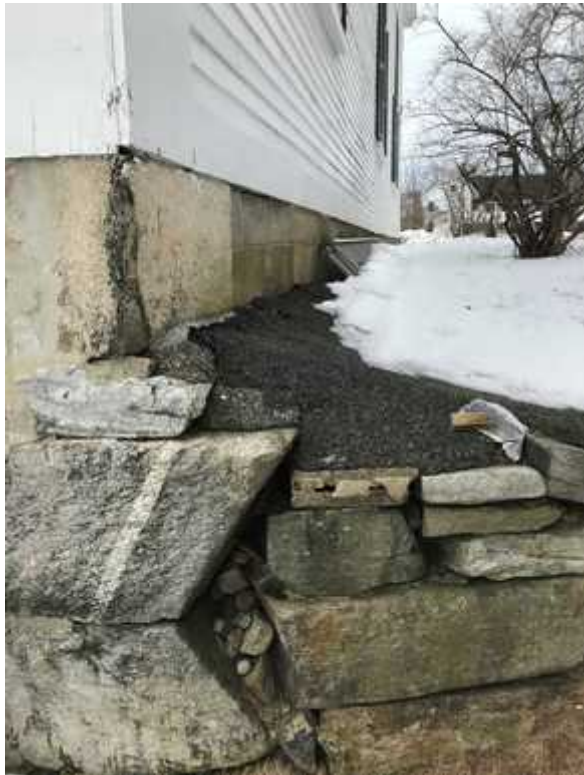
Photo 18: Northwest Foundation: Brown Granite just above grade

Brown granite superbly cut and uniform slabs make up the above grade foundation along the northwest eave wall. The asphalt drip line allows water to flow both away from the building with considerable voids trapping water behind the asphalt drip edge.

A retaining wall at the North corner retains the grade that was taken away when the building was excavated for classroom space beneath the sanctuary. It appears that the retaining wall suffers from decay and has been rebuilt more than one time. Rebuilding this wall will be a maintenance issue because of the asphalt drip line. Water can get behind the asphalt and collect at this North corner and cause movement in this stone wall.

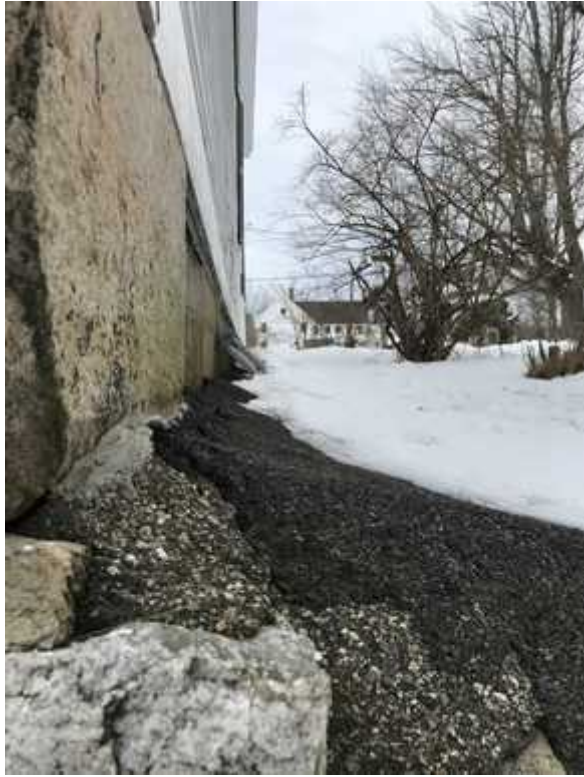
Photo 19: Northwest Foundation

A close up view of the asphalt drip line. It has been poured more than once and still allows water to get behind it and impact the foundation. Bushes are close along this line towards the rear of the church.

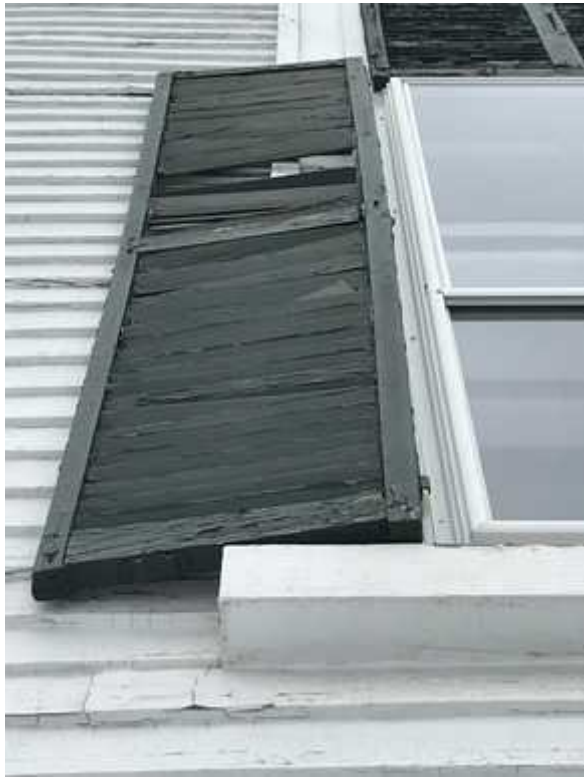
Photo 21: Southeast Facade: Shutters and Windows

Modern storm windows are placed over wood sash on the lower portions of the southeast facade windows. The shutters are made of wood and need to be repaired and painted.

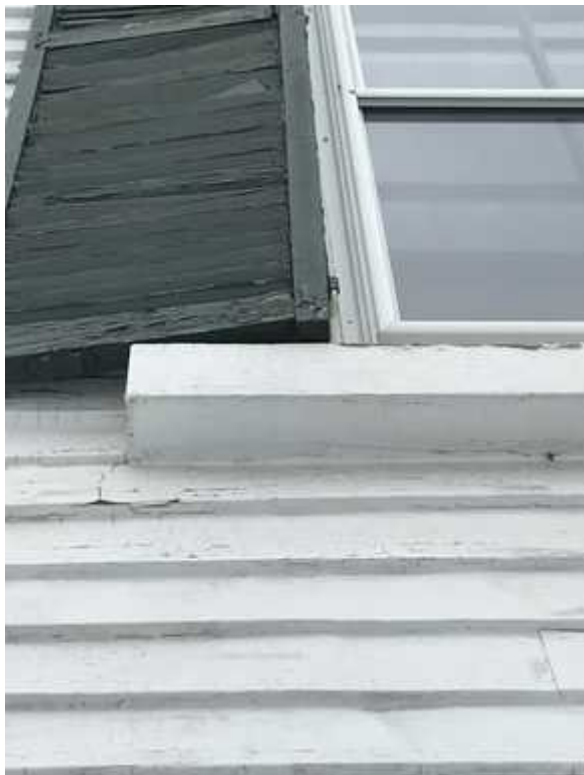
Photo 22: Southeast Facade: Window Sills

The windows on the church have heavy sills with wide trim. The windows are double hung and appear in good shape save for some needed glazing.

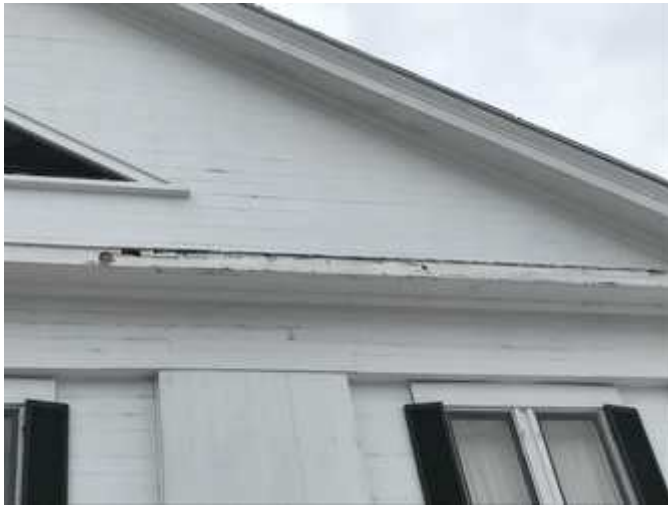
Photo 28: Southwest Tympanum

Greek Revival trim is failing across the front of the church. A ledge above the trim may need a copper cover to prevent future damage once this trim is repaired in kind.

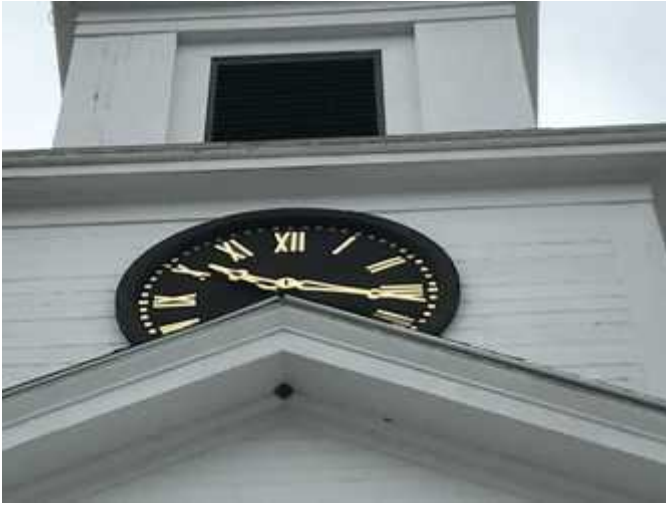
Photo 29: Steeple Base and Clock Face

The clock faces appear in very good condition. The flush board siding shows signs of wear and must be painted often to ensure that the walls are weather tight. Caulking should be kept to a minimum which does not appear to be the case here.

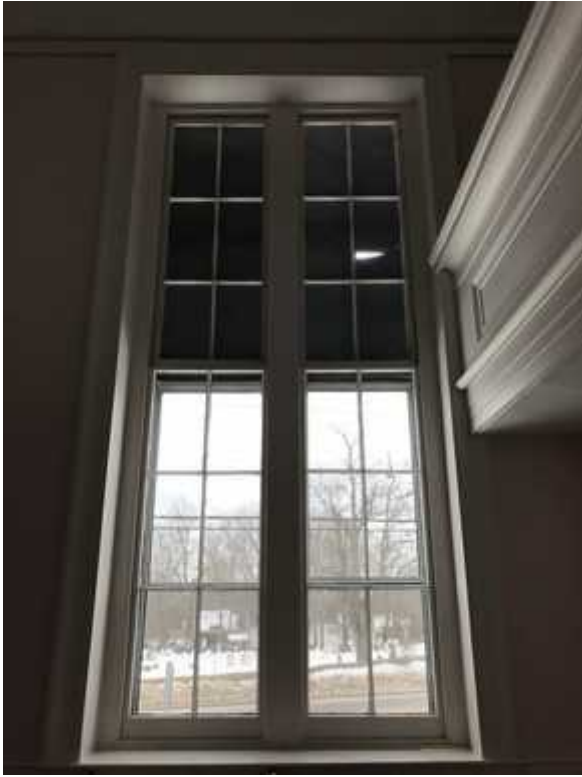
Photo 41: Sanctuary windows: 6 over 6

The six over six double window sash lets superb light into the sanctuary space and the windows are in excellent order save some needed glazing. Balcony trim intersects the window trim.

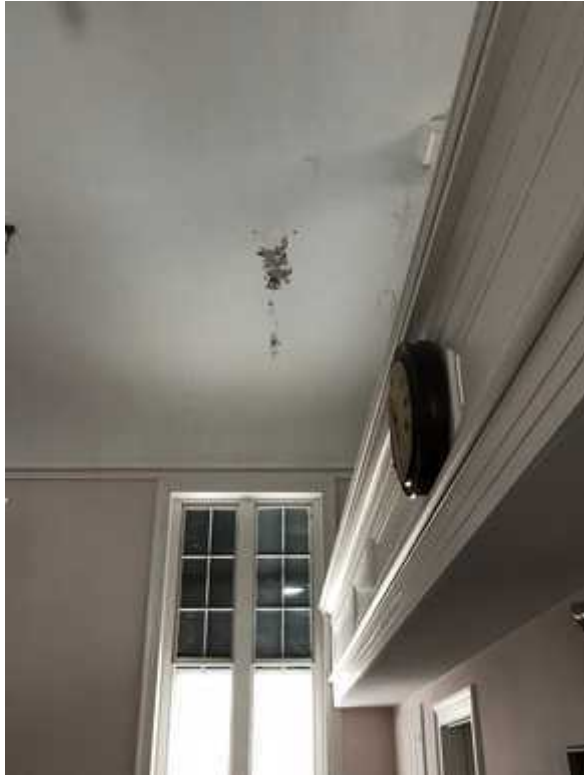
Water runs down hill from roof leaks above and damages the paint, plaster and ceiling lathe. Insulation above the ceiling can become drenched and hold moisture to the ceiling plaster.

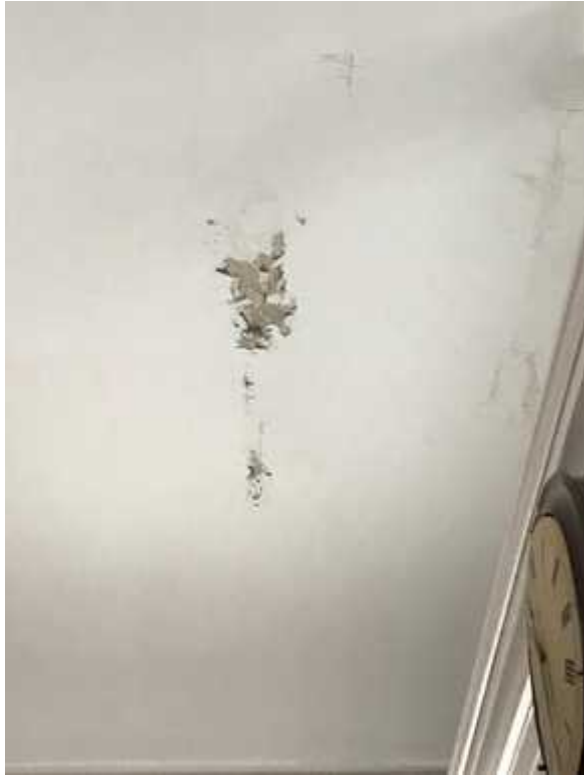
Photo 67: Sanctuary Ceiling

Ceiling damage over the balcony center. This aligns with the edge of the tower above.

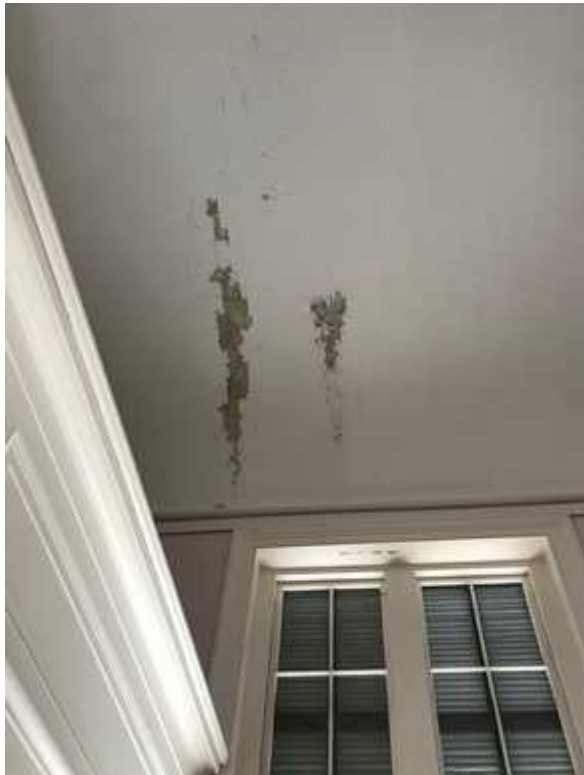
Photo 68: Sanctuary Ceiling

The ceiling over the balcony has been compromised from roof leaks above.

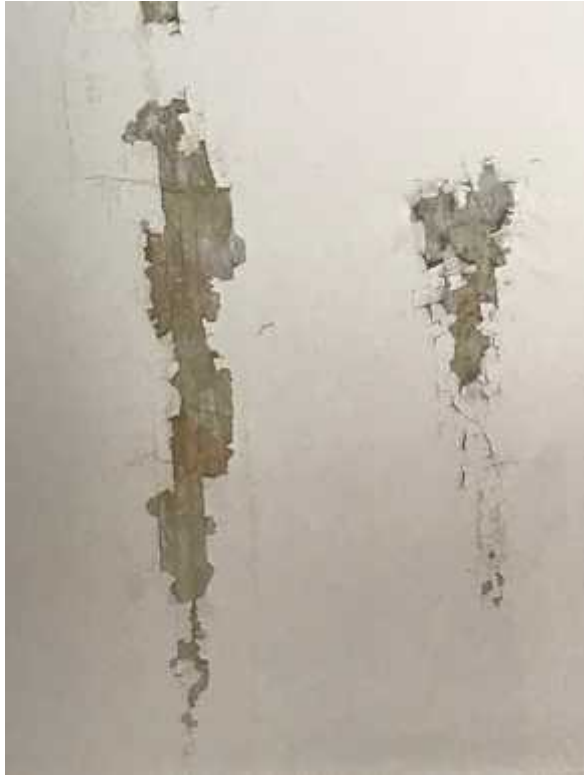
Photo 69: Sanctuary Ceiling

This is a close up of peeling paint in the ceiling of the sanctuary. This is the result of a flashing issue where the roof meets the tower. While the roof shingles appear relatively new, there are buckets in the attic space above this ceiling damage that collect water leaking into the attic space. It is difficult to determine how long the leak has been occurring, but flashing at the tower is the likely culprit.

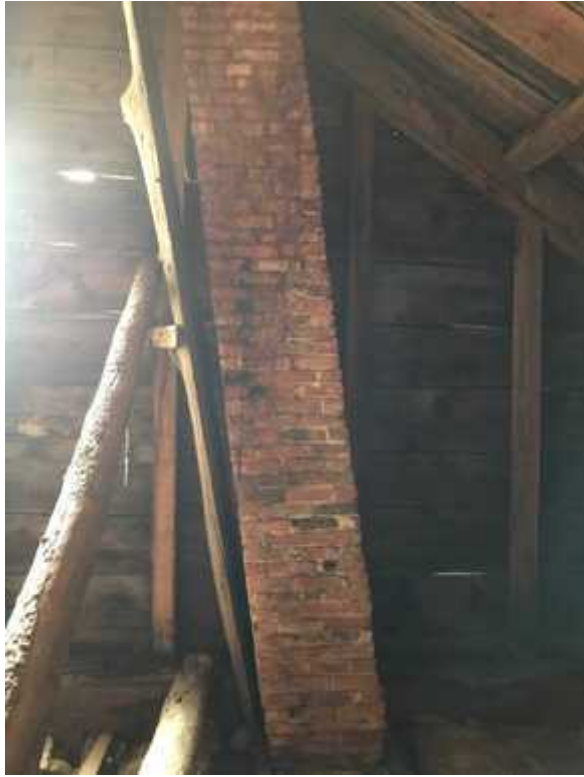
The chimney rises hidden in the sanctuary and then corbles out around the gable end tie beam rising at an angle to the roof. This chimney meets no modern safety standards. Its original wooden false work is still in place albeit rotten from flashing leaks above in the roof plane.

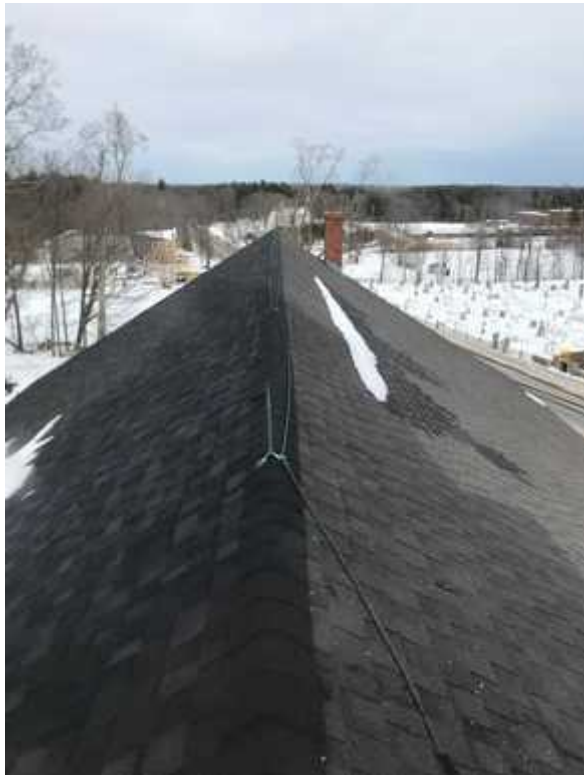
Photo 104: Asphalt Roof Covering

The asphalt roof covering appears in good shape save some leaks through the flashing at the interface with the tower. Simple lightning protection traverses the ridge.

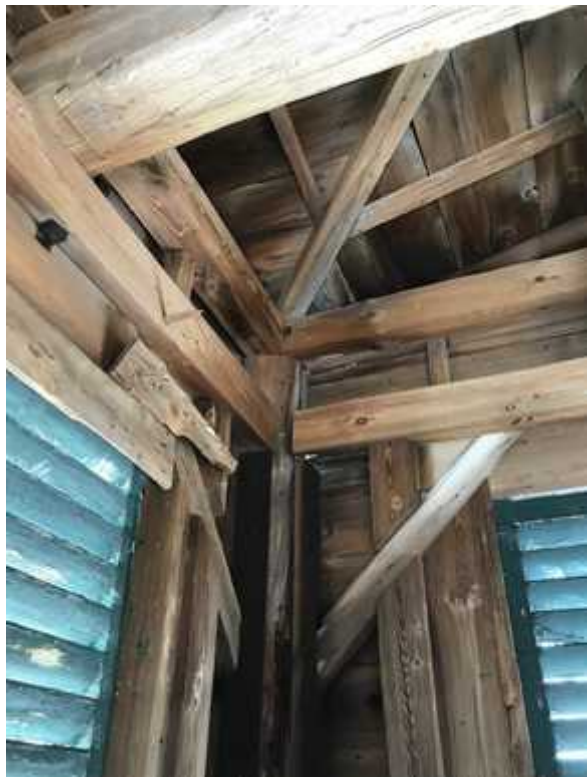
A parallel girt just below the belfry post top plate accepts the spire frame from above. The top plates and the spire girts at the West corner show signs of water damage, mold and rot. They will need to be repaired when the belfry post is replaced.

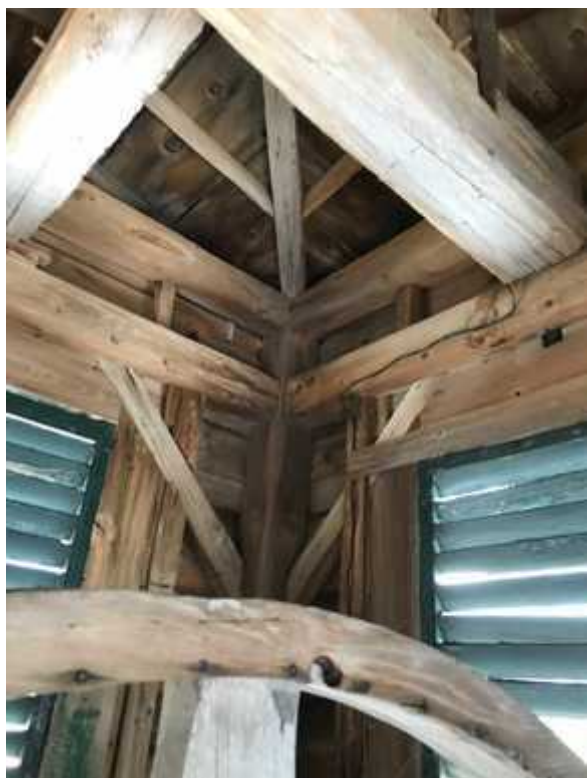
Water damage does appear to be prevalent at the base of the spire.

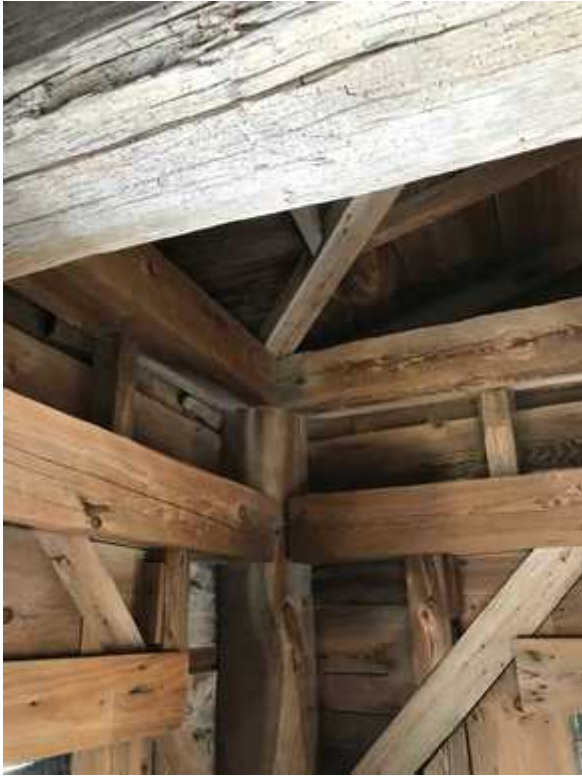
Photo 119: Spire Base Frame

The base of the spire frame is created in heavy timber showing some decay but sound.

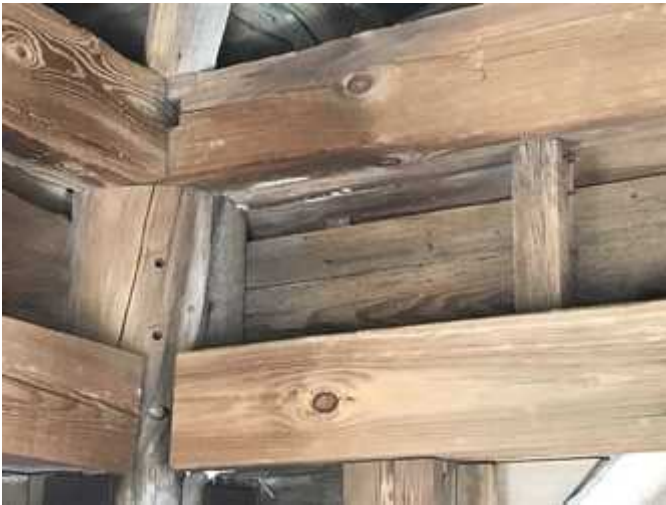
Photo 128: Belfry Top Plate and Spire Girt

The West corner of the belfry shows signs of white mold and decay from a roof leak from above in the spire roof.

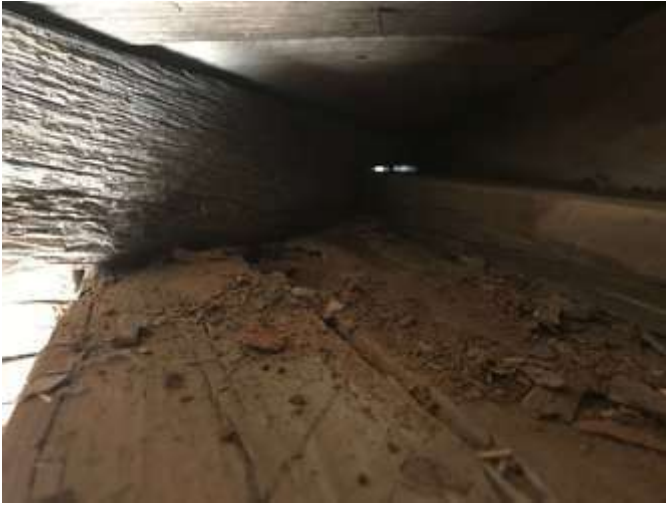
Photo 129: Belfry Southeast Top Plate
Looking East along the Southeast Belfry top plate, you can see extensive rot and daylight through the belfry roof.

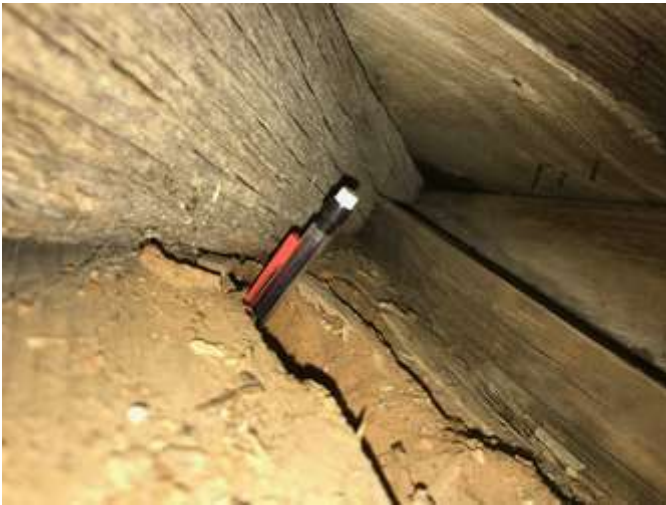
Photo 130: Belfry Southeast Top Plate
The southeast top plate of the belfry frame is completely rotten.

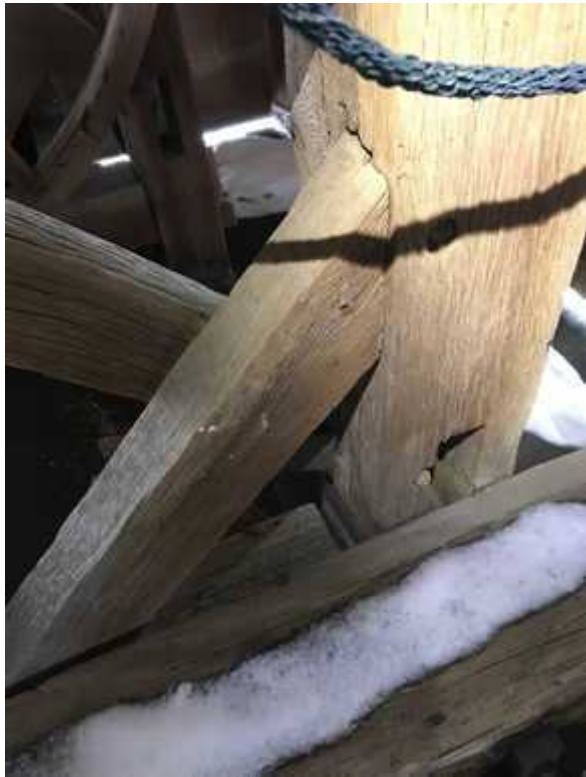
Photo 131: Bell Cradle

An ancient bell cradle, very likely from the earlier meeting house support the bell. The cradle is white oak with ascending and descending braces for stiffness. Some repairs are needed on the post tops.

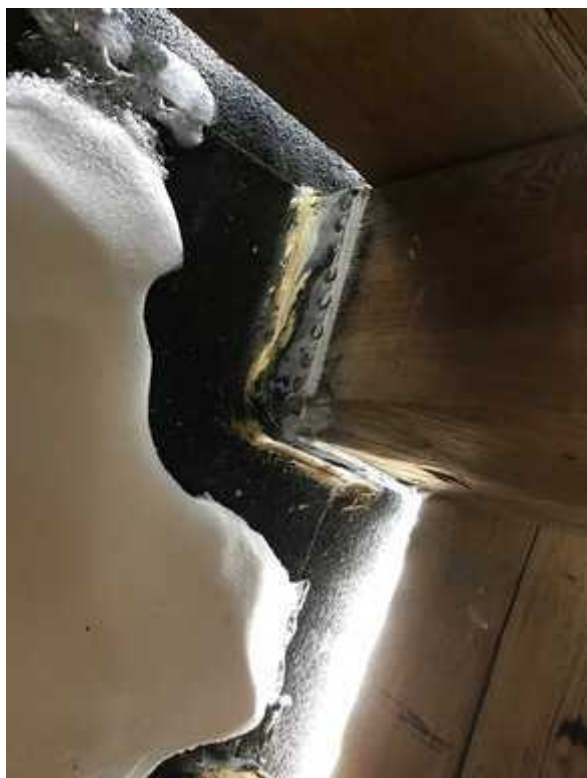
Photo 138: Belfry Roof

Rolled roofing covers the belfry hip roof. It is very difficult to keep this roof from leaking. The rolled roofing turns up the belfry post and is nailed on the face of the post. This provides no counter flashing and invites water to the belfry interior.

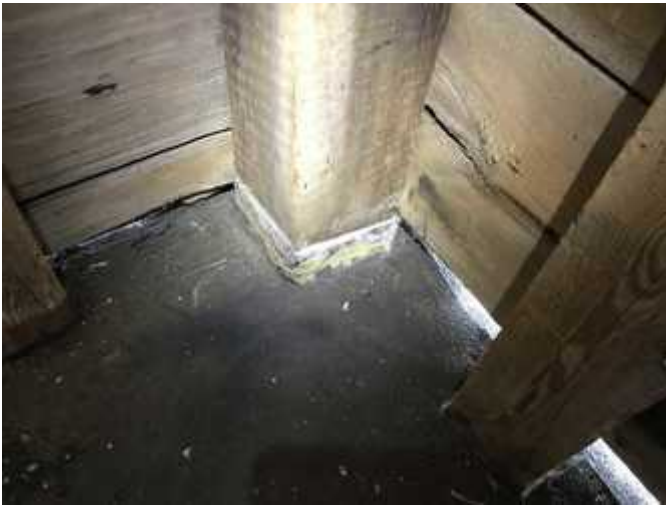
Photo 140: Belfry Roof

Caulking has been applied to the face of the post to help keep the roof from leaking. This can help in the short term, but becomes an accelerant for decay once water begins to penetrate the caulking.

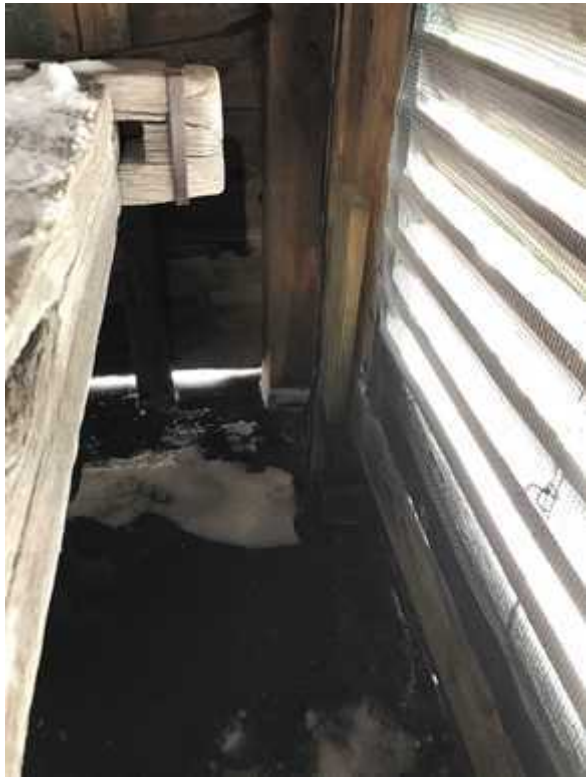
Photo 141: Belfry Roof

The belfry roof has very little room to move around. The bell cradle must be lifted off the roof along with the bell to correctly repair the belfry roof. The roof would be replaced with copper from outside staging to access this level of the steeple.
