CHESTER CONGREGATIONAL CHURCH

PHOTO REPORT MARCH\APRIL 2018

By Arron Sturgis on March 26, 2018

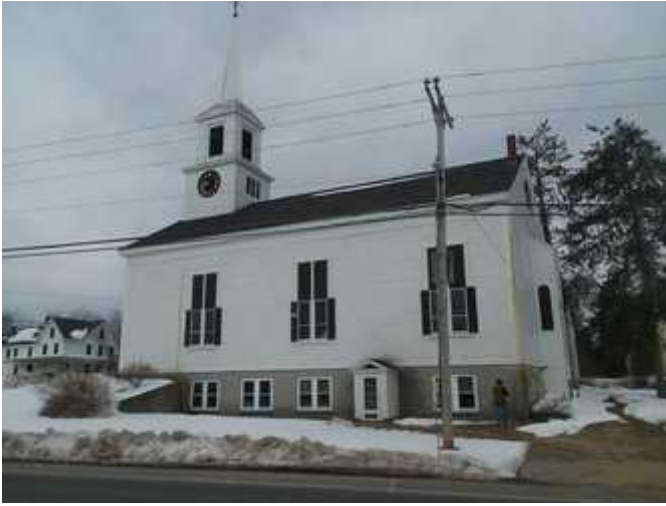
Photo 3: Southeast Eave Wall

This eave faces Southeast. A full basement supports the sanctuary, Narthex and Tower.

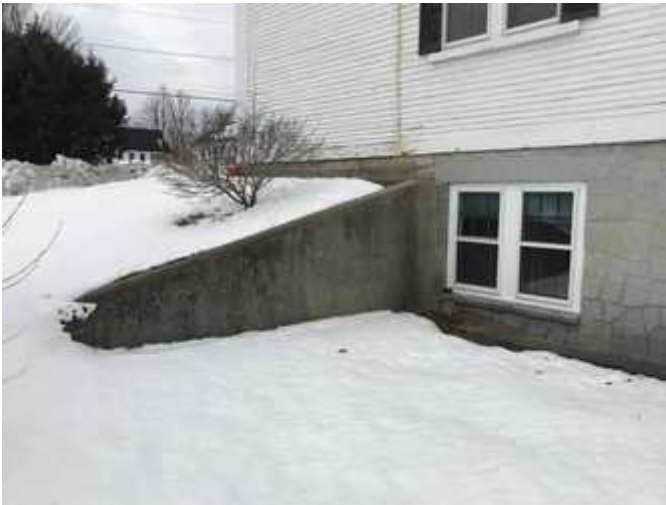
Photo 4: Retaining wall

In the 1960's the church cellar was dug out to insert a lower level for classroom and community space beneath the sanctuary. The retaining wall creates a transition from higher to lower grade.

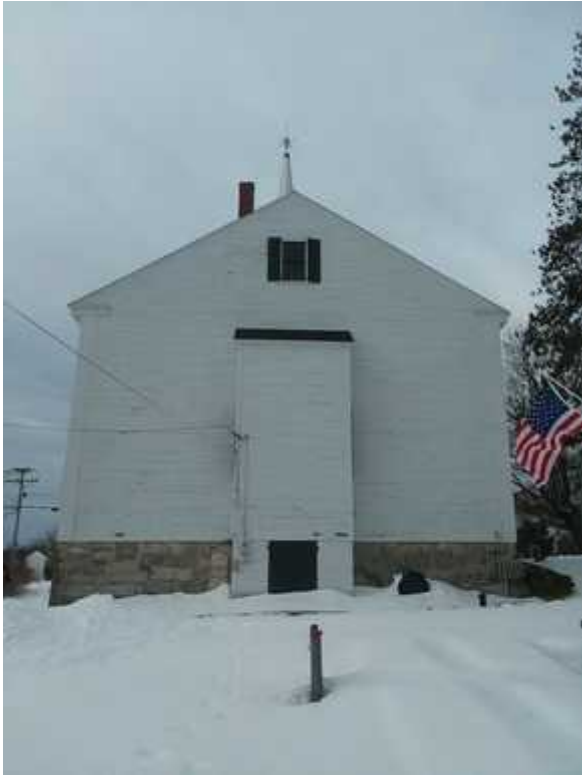
Photo 5: Northeast Facade

The Northeast gable end of the church contains a center bump out that provides a recessed arch into which now sits the pipe organ.

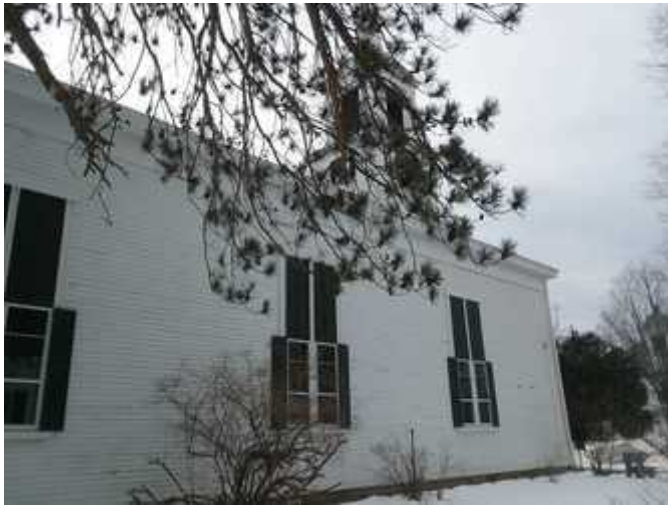
Photo 6: Northwest Eave Wall

The northwest eave is a grade with brown granite cut stones visible above grade.

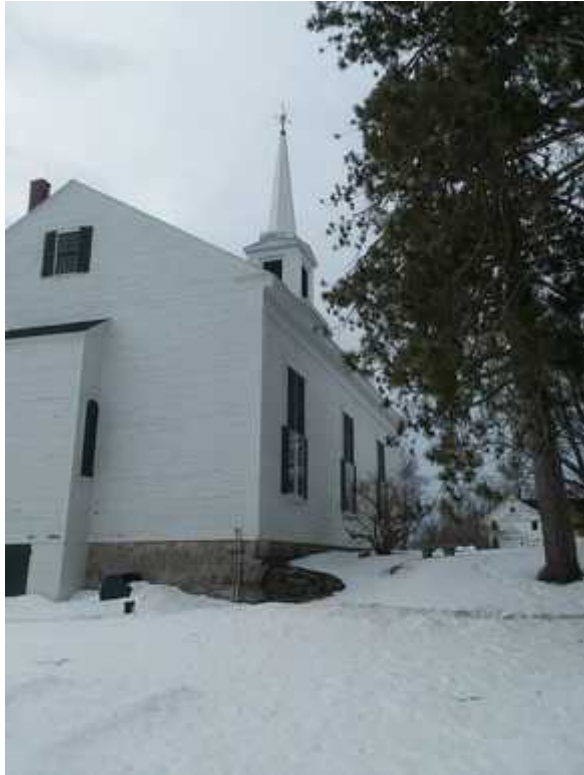
Photo 7: North Corner

The North Corner of the church also has a shallow retaining wall that contains a higher grade along the Northwest eave wall.

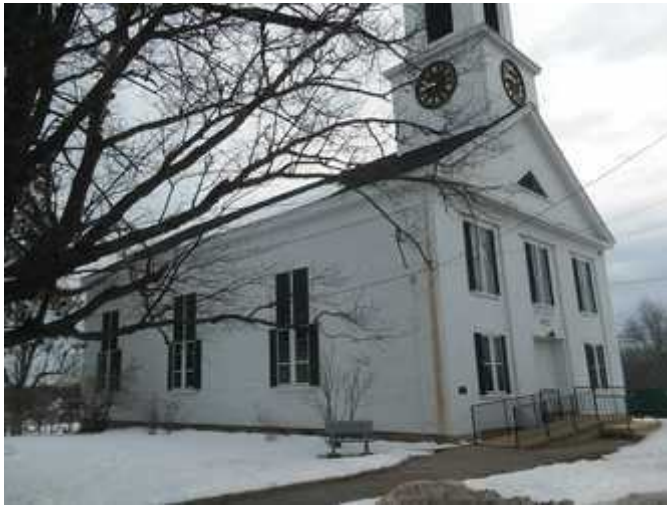
Photo 8: West Corner

The West corner of the church contains the beginning of an accessible ramp to the two front entry doors.

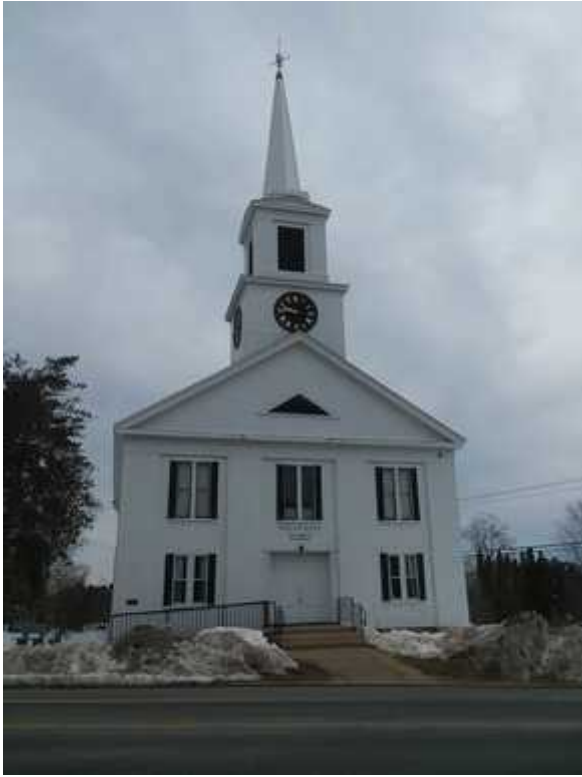
Photo 9: Southwest Facade and Steeple

A Greek Revival Front Facade completes the church. The tower contains a clock in the tower box frame supporting a belfry frame with louvers finally topped by a four sided spire.

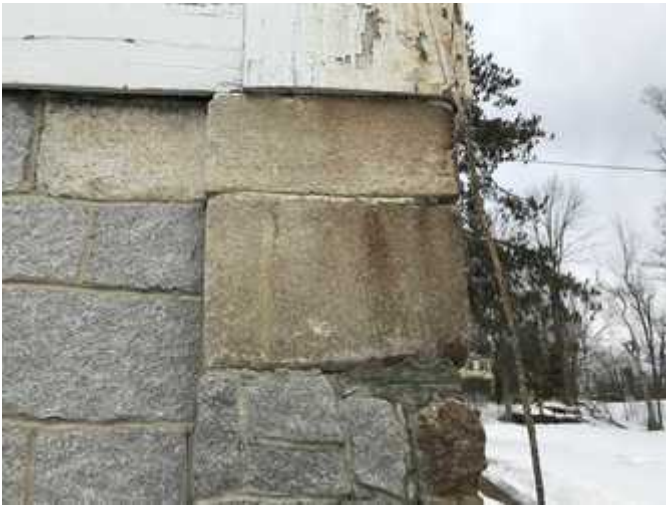
Photo 10: Brown and Blue Granite Foundation

This is the East corner of the added foundation under the Chester Congregational Church. Note the brown granite placed adjacent to the blue granite. Major work was done to create space beneath the sanctuary according to written history in the 1960's.

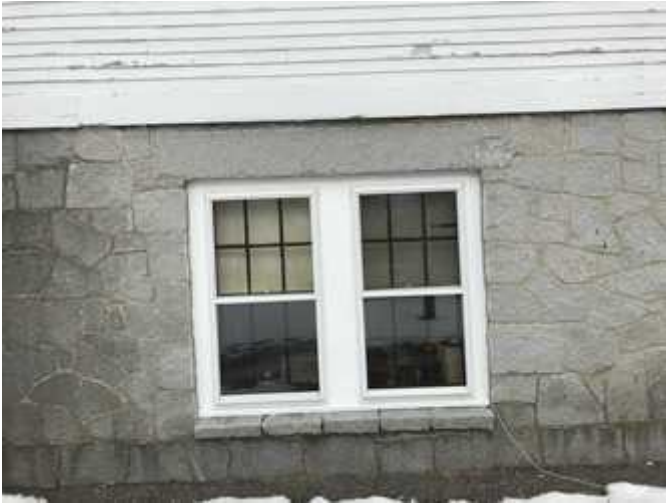
Photo 11: Southeast Wall: Blue Granite and New Windows

The blue granite is well done with mortar and windows have stone lintels, one piece. Sills are numerous pieces of stone.

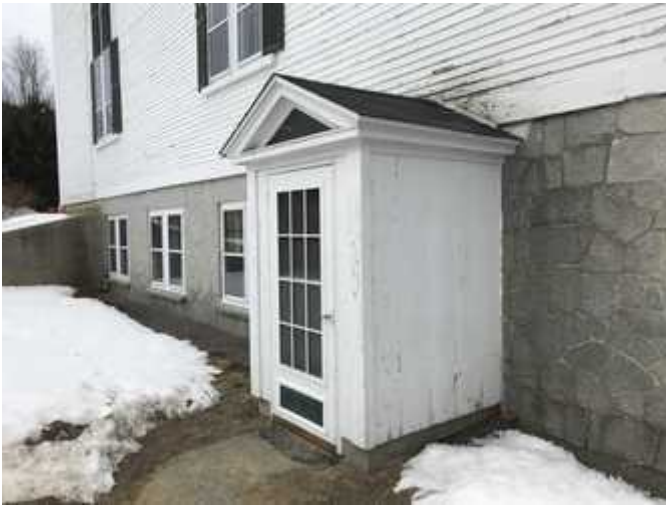
Photo 12: Ground Floor Entry: Southeast Foundation

This dog house entry allows almost at grade entrance to the cellar community space under the sanctuary. One steps down to the cellar floor just inside this entry to offices and class room spaces.

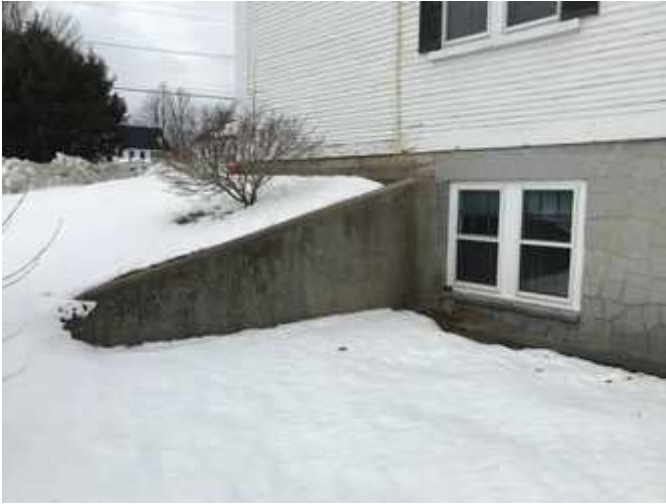
Photo 13: Retaining wall: Southeast Foundation

As the original ground was dug away from under the church in the 1960's to allow for a parish hall and classroom space, this retaining wall was necessary to make the grade change and allow windows and doors to light the community space at grade.

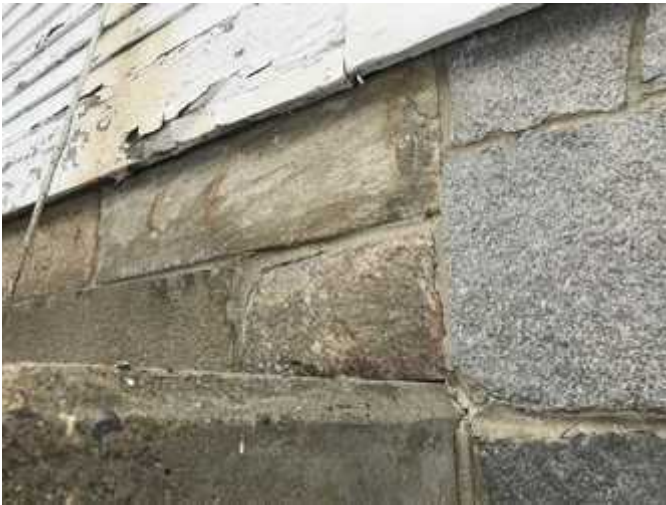
Photo 14: Southeast Foundation: Blue and Brown Granite

Blue Granite meets brown where the grade rises towards the front/Southwest facade of the church. The blue and brown create a distinct contrast.

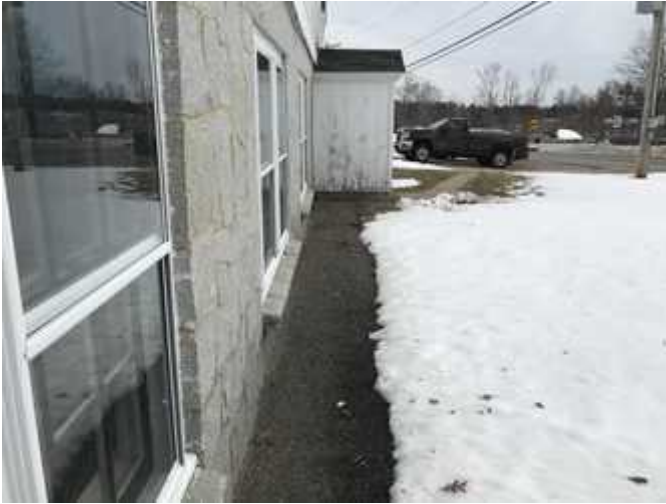
Photo 15: Southeast Foundation:
Asphalt drip line

An asphalt drip line has been laid up at the base of the eaves and follows the perimeter of the foundation save the front/west facade. It catches and directs water from the roof in most cases away from the structure.

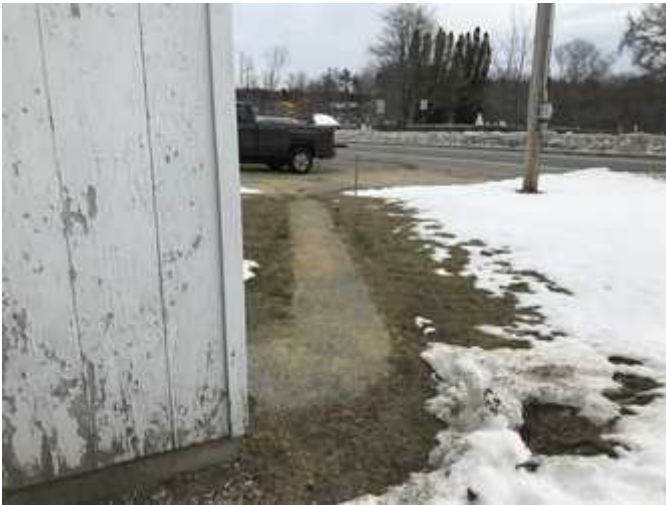
Photo 16: Southeast Foundation: Dog
house entry and walkway

Vertical boards sheath the entry and a small asphalt walkway passes to a dirt parking area along the east and south end of the church.

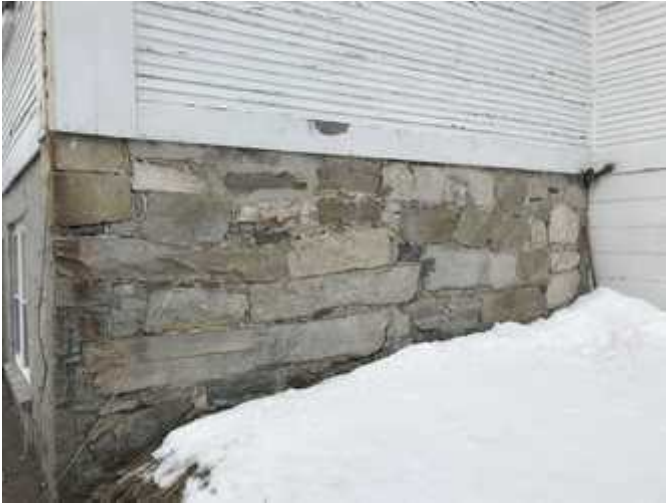
Photo 17: Northeast Foundation: Brown Granite

The grade rises along the Northeast wall showing a brown granite foundation of cut stone ascending to a center small bump out for the interior pulpit and organ area. Wide corner boards and a mop board provide a Greek Revival style to the building exterior. Clapboard reveal is 3.5 inches on the south and east facades.

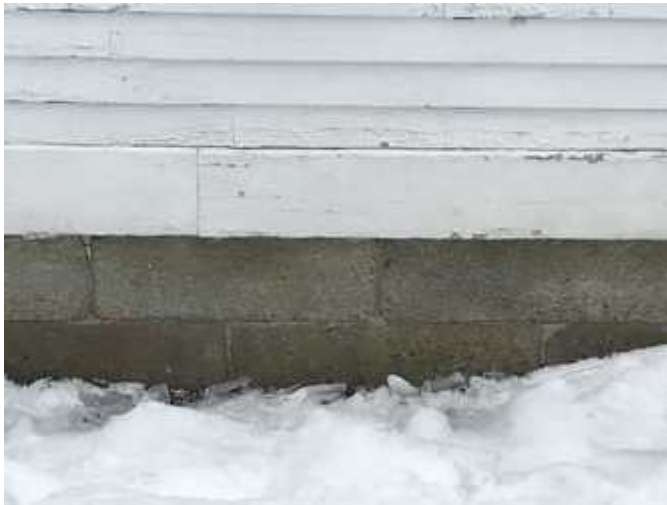
Photo 20: Northwest Foundation:
Dressed granite above grade

The dressed block foundation along the north eave wall is extremely well executed with very small mortar joints. This wall is visible from the road.

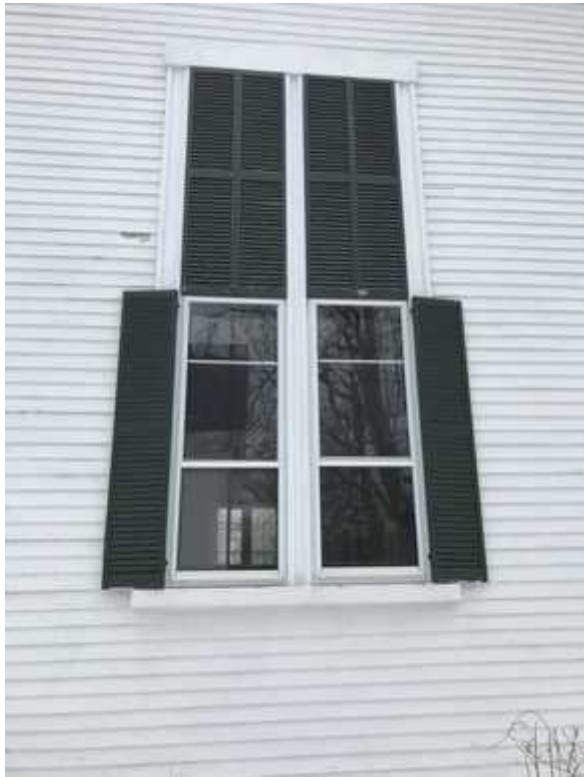
Photo 23: Northwest Facade Windows

The Northwest windows and shutters are in better shape than those along the southeast wall. Heavy sills with a pair of large double hung sash with divided lights make for uniform fenestration and wonderful light in the sanctuary space.

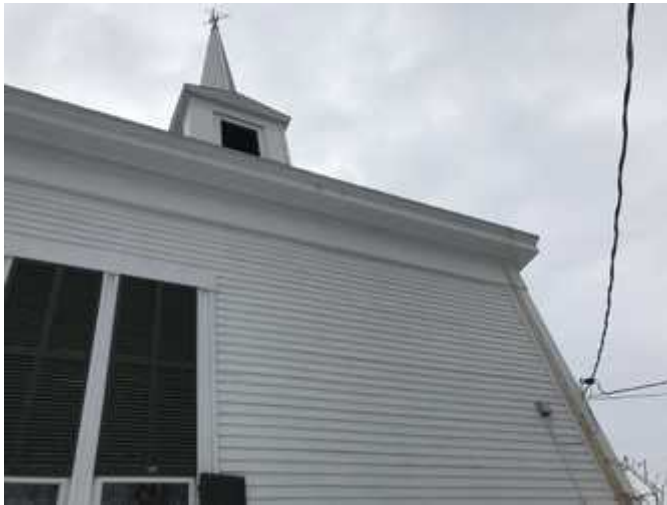
Photo 24: Northwest Facade: Roof eave details

A wide frieze supports a small soffit created by boards nailed to the ends and underside of the tie beams. A fascia and crown molding creates the dressed overhang.

Wide corner boards and a large pitched head casing complete the Greek Revival motif. Clapboards along the northwest eave wall have a reveal of 4 inches to the weather.

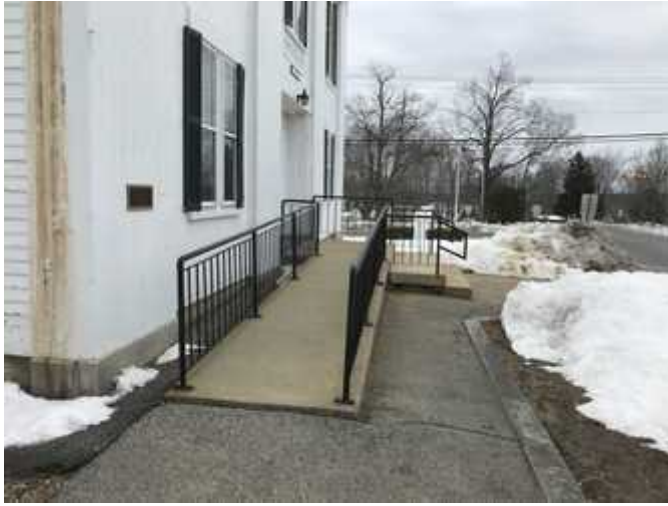
Photo 25: Southwest Accessible Ramp

Dressed granite cap stones are masked by an asphalt drip line followed by a concrete accessible ramp. Black railings rise with the ramp to access the front entry door.

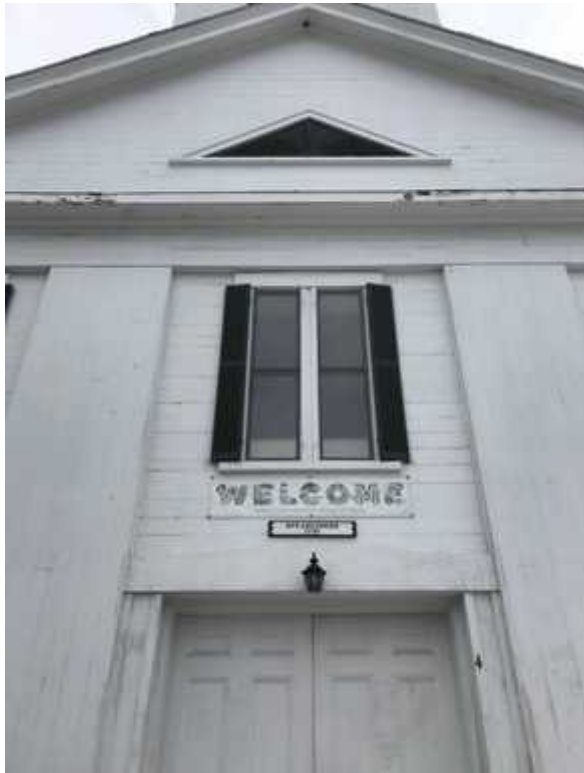
Photo 26: Greek Revival Flush Board Siding

This facade created with flush boards and Greek Revival trim elements encapsulates the original tower box. The 1733 tower measures 14 feet square and remains part of the front wall of the church. Northwest and Southeast wings were added to make the tower flush with a new front facade c. 1839.

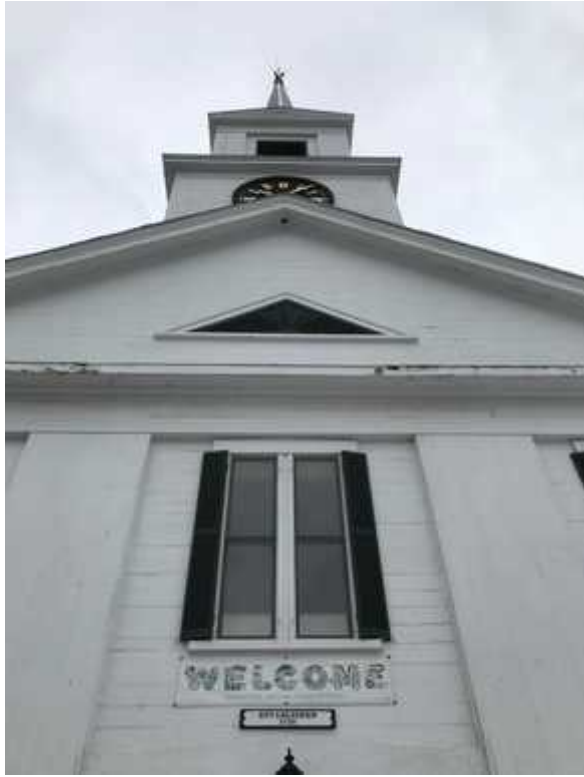
Photo 27: The Steeple

Standing at ground level, the tower rises through the roof pitch and incorporates a clock in the tower base frame. The Belfry frame above extends from the tower base frame and the spire sits atop the belfry top plates. The spire is reinforced by a "low battered die with recessed horizontal panels" as described in the National Register Nomination. This trim detail reinforces the base of the spire and resists wind loads. It is deteriorated and losing paint. It also appears that the roof leaks at the base of the clock level where it meets the asphalt roof.

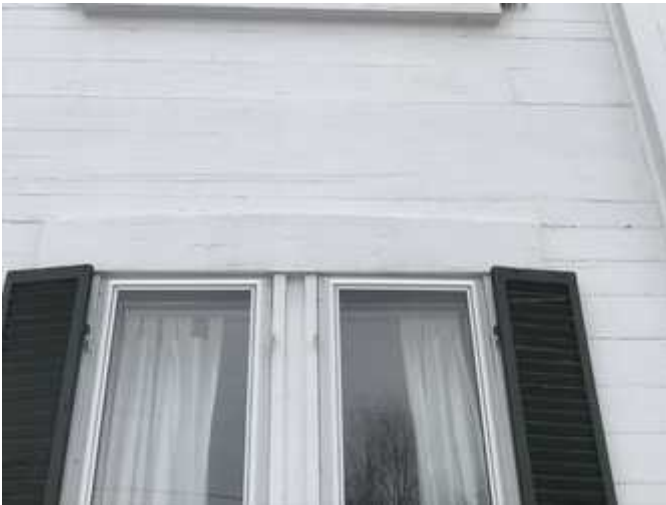
Photo 30: Southwest Facade Windows

Large one over one sash are in place in the front facade of the church. They appear later than the divided lights in the sanctuary. The openings appear to match the trim elements from the c.1839 upgrades to the Greek Revival form.

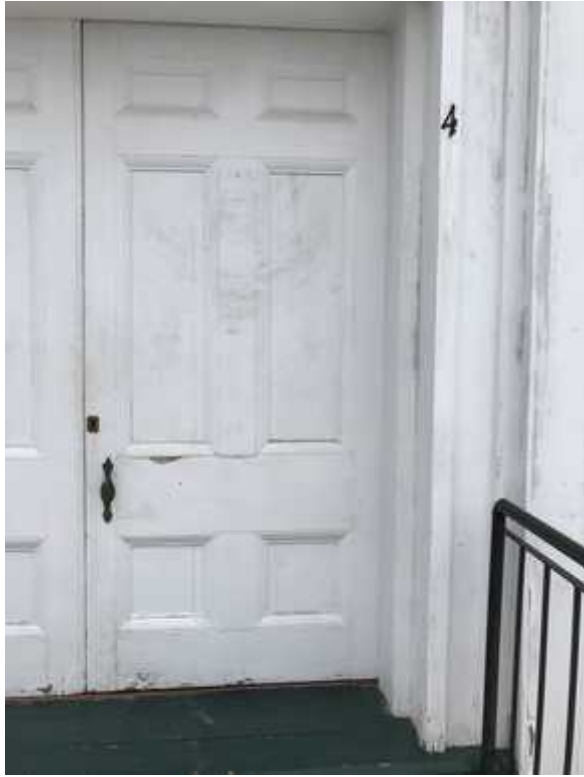
Photo 31: Southwest (Front) Entry

A large pair of double doors provide entry to the narthex. Wide door trim and side jambs give depth to the entry. A small ramp threshold provides accessible entry to the narthex from the ramp.

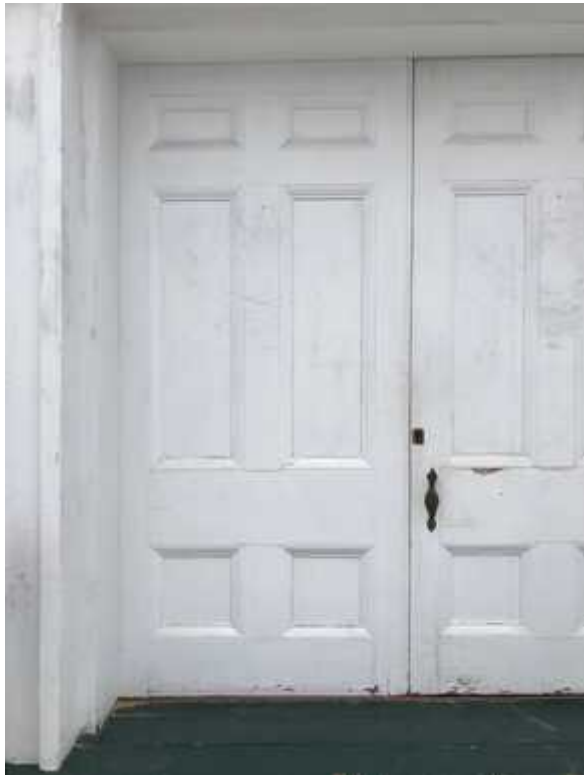
Photo 32: Southwest Entry Facade

The entry doors swing into the narthex and the depth of wall is the result of the large 12 inch square tower posts that are within the finished wall plane of the west wall.

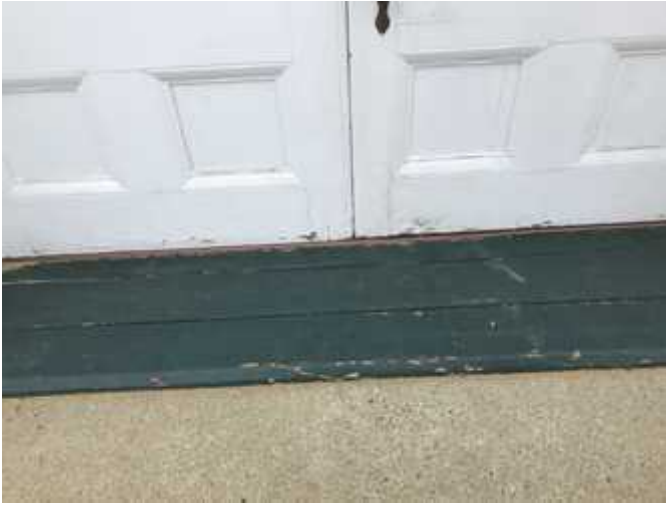
Photo 33: Entry Threshold

The accessible ramp sits adjacent to a shallow threshold designed for easy access into the narthex.

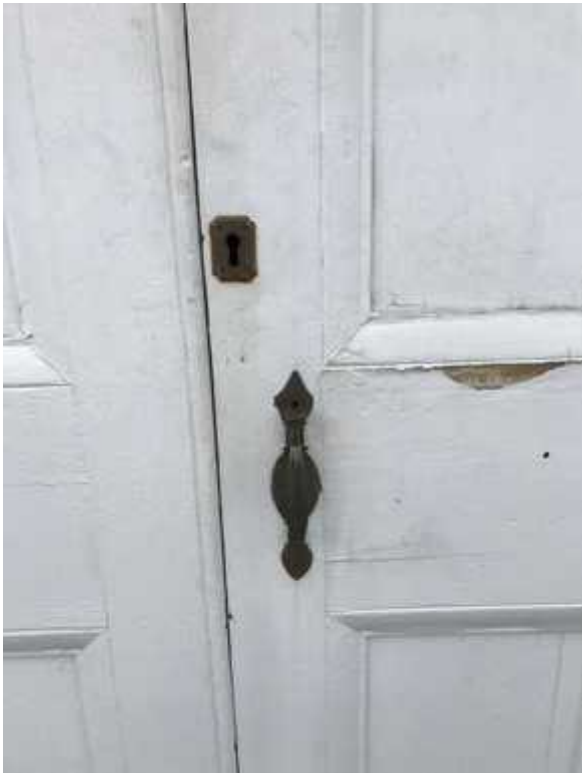
Photo 34: Entry door hardware

Greek Revival double doors host early hardware and lockset.

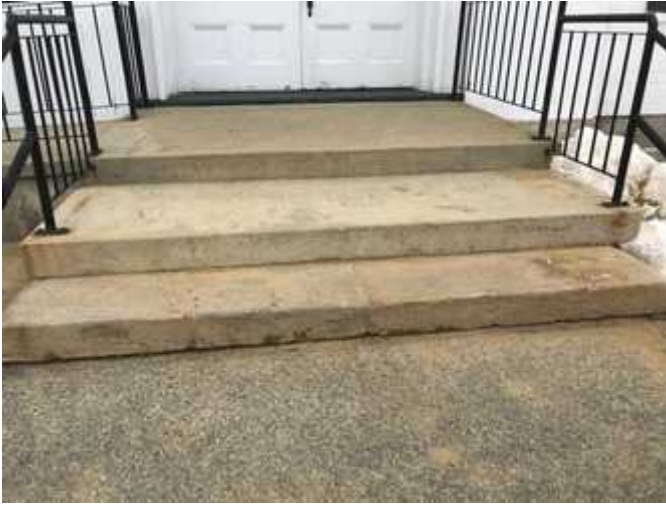
Photo 35: Southwest Entry Steps

A concrete walkway for accessible entry is flanked by what appears to be the original dressed brown granite stairs that likely provided access to the double doors. The stone steps are wonderfully sculpted and blend naturally into the ramp and railings.

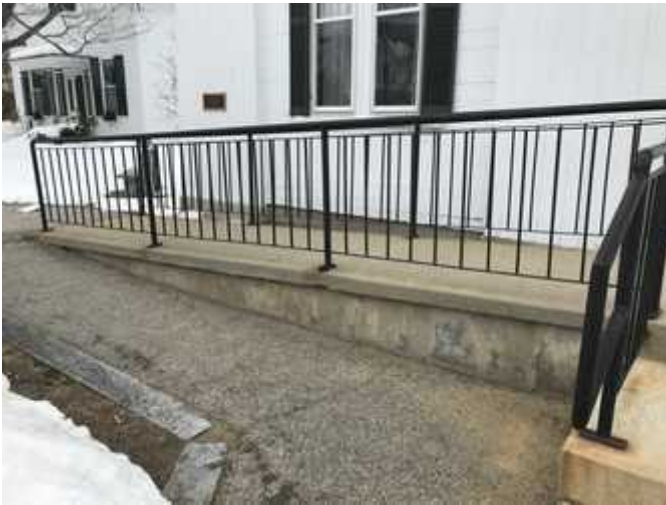
Photo 36: Accessibility

A near code compliant ramp rises from grade to the front entry of the church. It is created in concrete with an asphalt skirt.

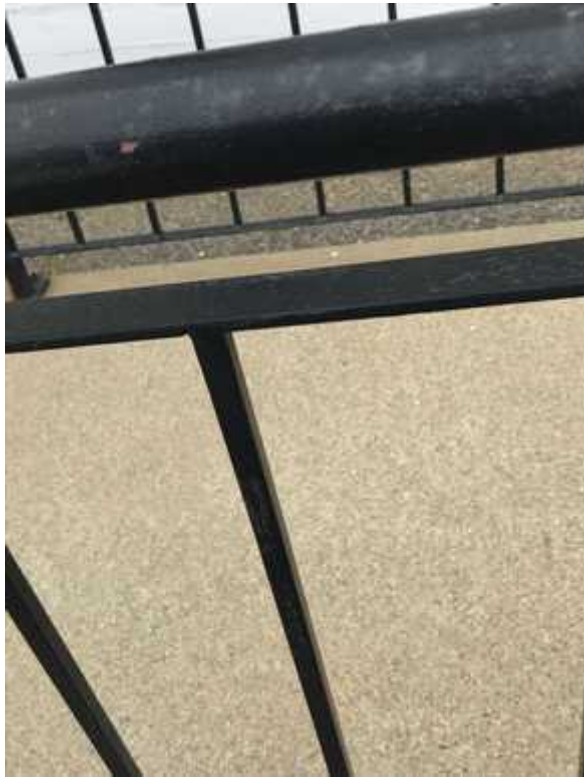
Photo 37: Southwest accessible hand rails

Accessible hand rails flank the concrete ramp to the front entry of the church.

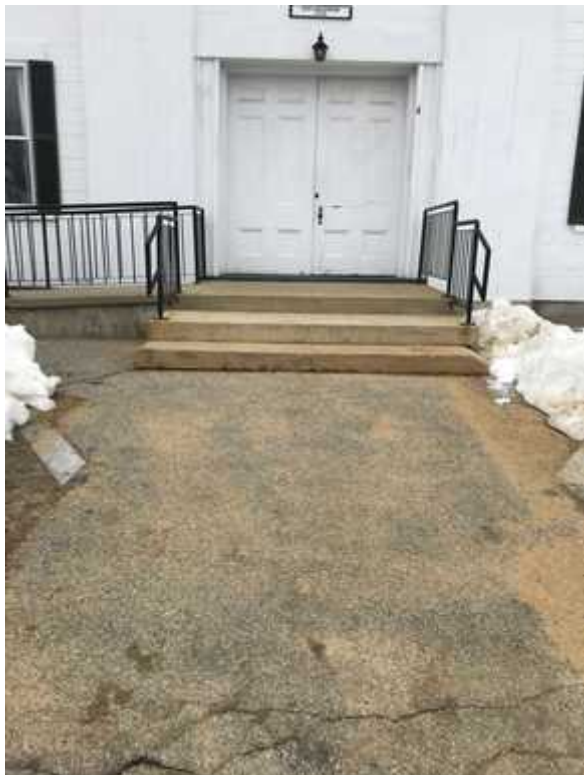
Photo 38: Front Facade

From Rout 121, the church is accessed from an asphalt pathway.

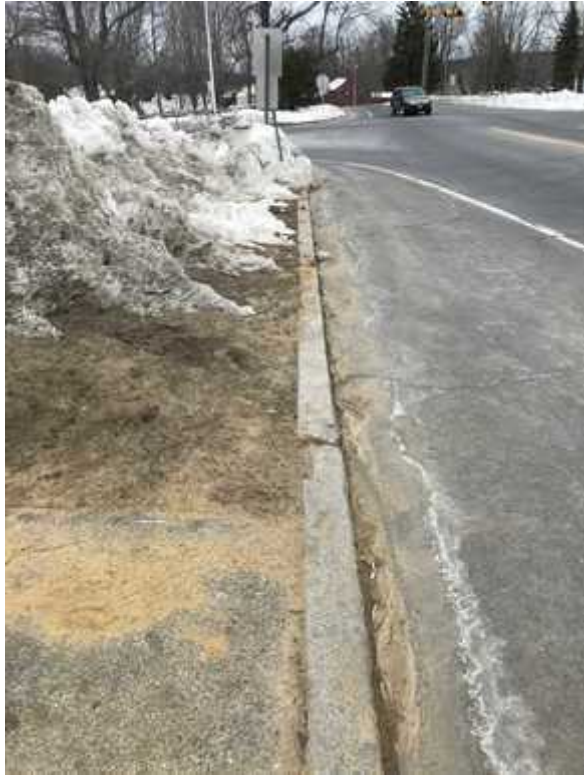
Photo 39: Route 121 and 102

The church sits on the corner of routes 102 and 121. Route 121 in the foreground leaves little room for drop off and pick up in front fo the church.

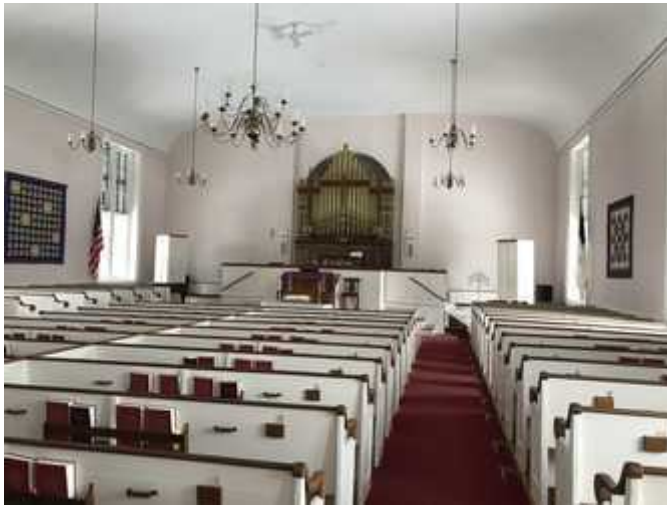
Photo 40: Sanctuary Interior

Slip seat pews without doors adorn the floor of the sanctuary. These date from the 1839 renovation. The coved ceiling is elliptical and the walls hide original heavy timber framing posts at each roof truss. An original cove remains above this ceiling and behind these walls that exposed the posts into the space. The posts are painted a yellow/gold. Additional photos provided above the ceiling level.

An organ sits in front of an arched bump out that protrudes from the rear/ Northeast gable of the church. The wide trimmed columns are actually covering structural gable end columns in this rear wall.

Six over six windows adorn and light the sanctuary. Walls and ceiling in very good shape.

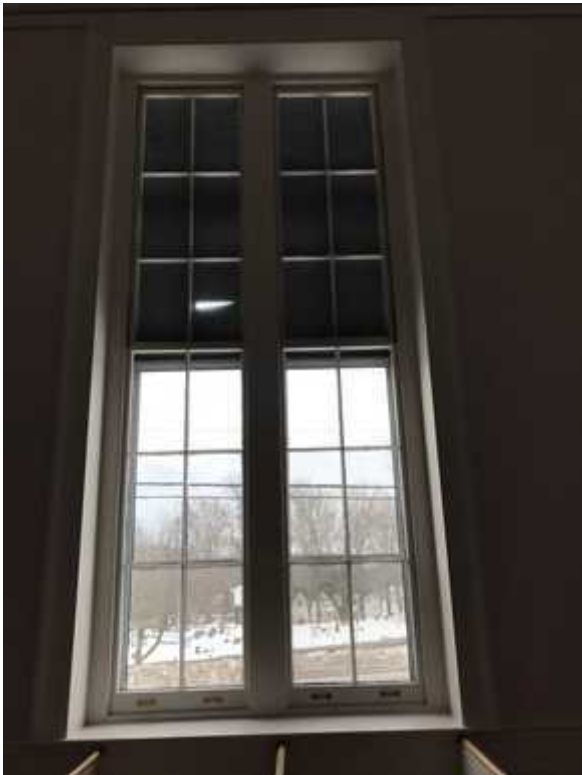
Photo 42: Sanctuary Windows: 6 over 6

Windows are operational with lower sash covered by a storm window on the exterior. Upper windows are protected by closed shutters.

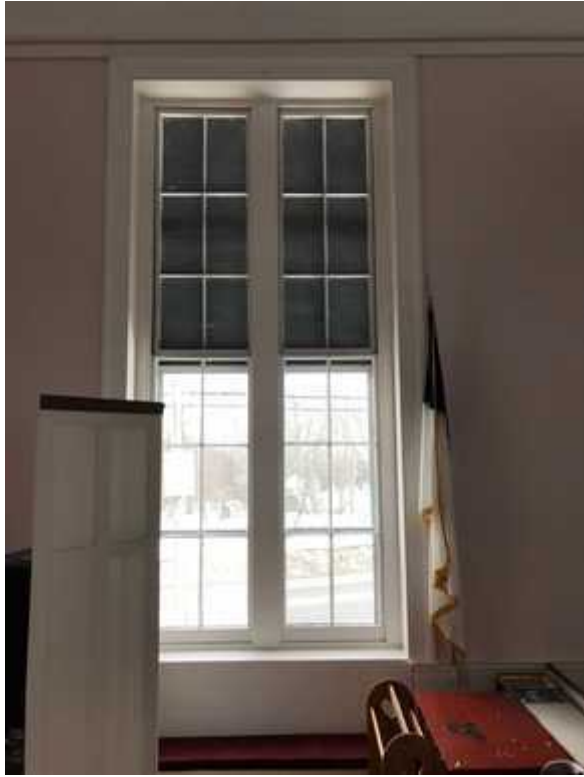
Photo 43: Sanctuary Windows: 6 over 6

It appears that these windows may have been a part of the 1839 renovation. They are well cared for.

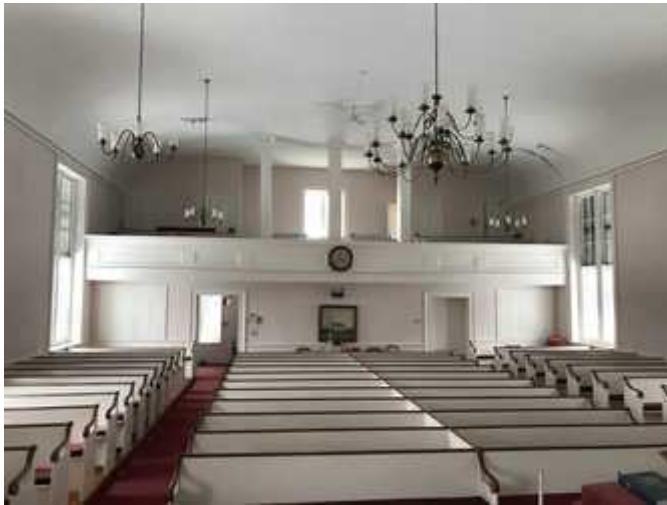
Photo 44: Sanctuary Balcony

The Sanctuary has a balcony over a structural Narthex wall. The Narthex wall was the original meeting house gable end. The Narthex ceiling hides the cantilevered framing of the this balcony. Three columns rise from the balcony up through the narthex wall. Two columns are structural with heavy tower base frame posts passing through boxed trim. The center column is hollow and boxes in the bell rope and clock weights.

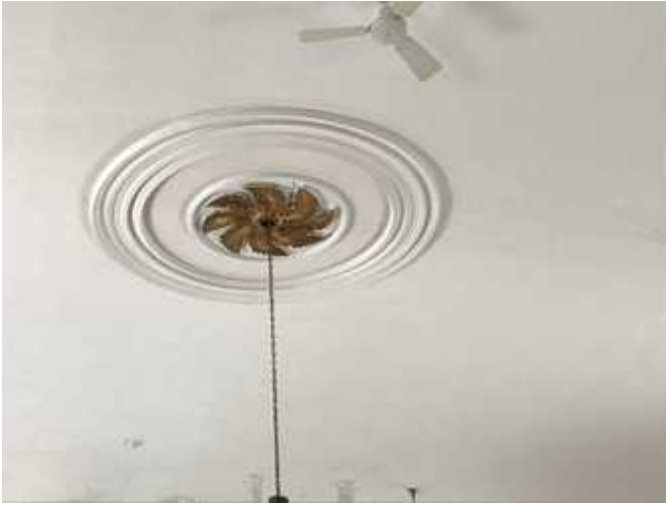
Photo 45: Sanctuary Ceiling

The sanctuary ceiling hosts a center medallion created in plaster. This ceiling level is close to the original ceiling level of the meetinghouse but the cove has been lengthened and brought to an interior wall that covers what was once an exposed and dressed timber frame.

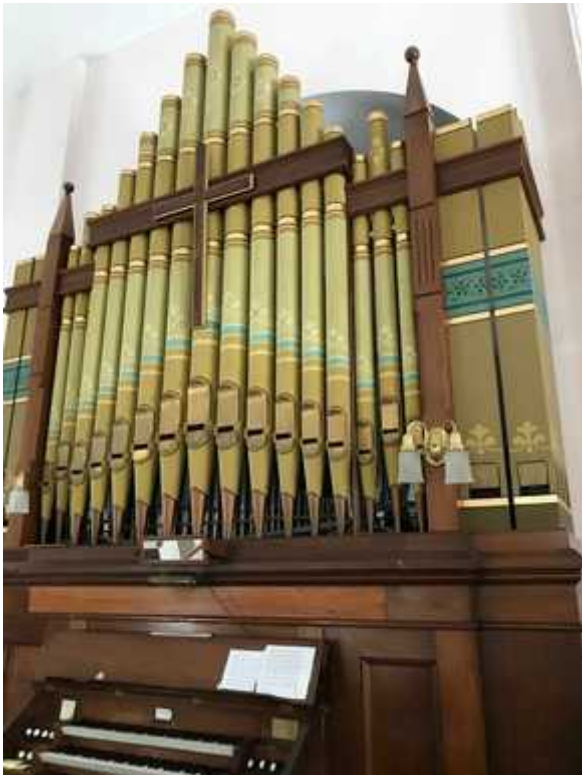
Photo 46: The Organ

The pipe organ is highly decorated and wonderfully finished. It sits at the rear of the pulpit slightly elevated from the podium. It runs in front of an arched opening at the rear gable of the church.

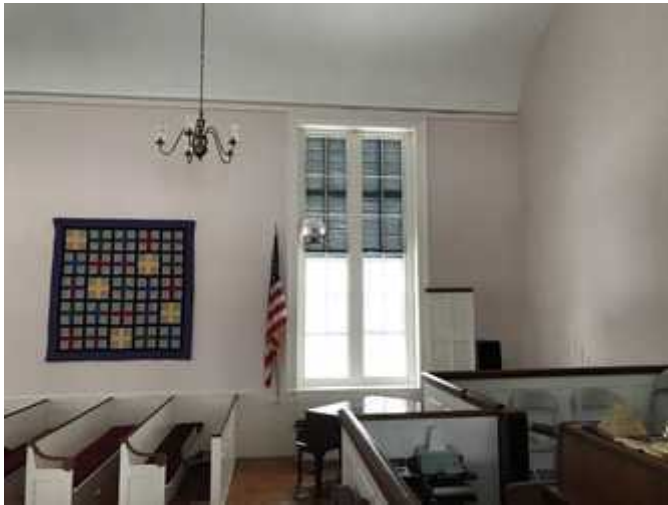
Photo 48: Sanctuary Pulpit

Slip pews were removed towards the pulpit of the church to make way for an upgraded pulpit and choir loft.

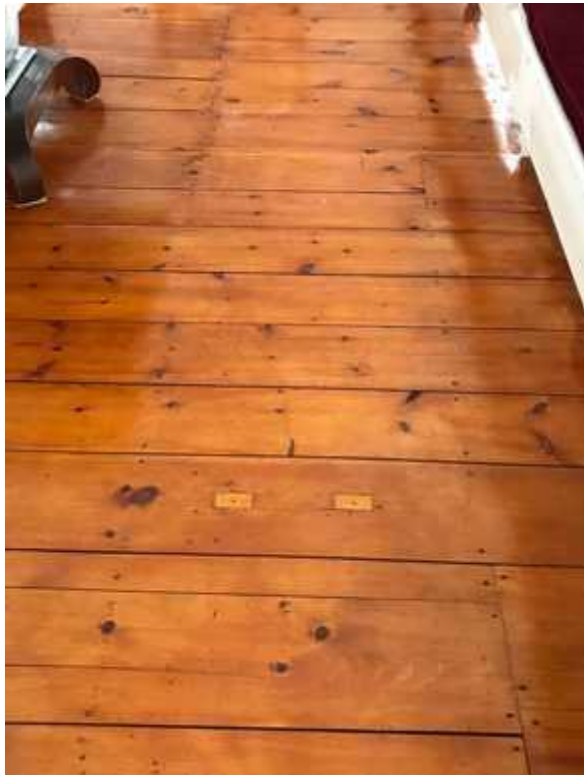
Photo 60: Pews and Flooring

The slip pews are mortise and tenoned into the floor system. Some pews were removed for the new larger pulpit and the flooring repaired with small dutchman patches.

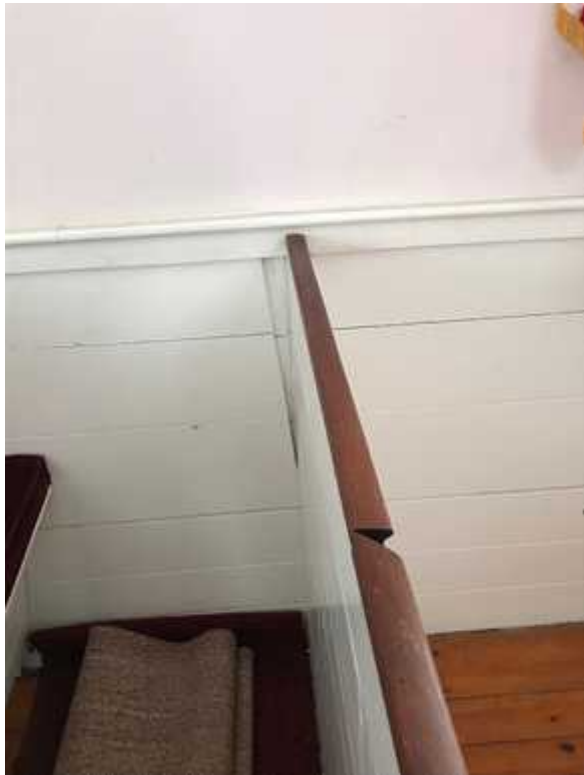
Photo 62: Pew Fronts

The pew front sits where once stood an additional slip pew. The groove for the pew is visible in the flush board wainscot.

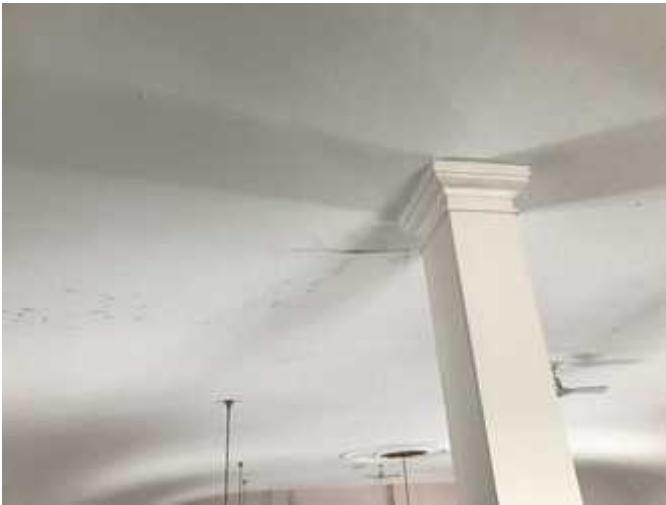
Photo 64: Structural Columns

The structural columns are part of the 1733 tower frame. Some stress around the columns is visible in the ceiling plaster, likely the result of flashing issues at the roof plane.

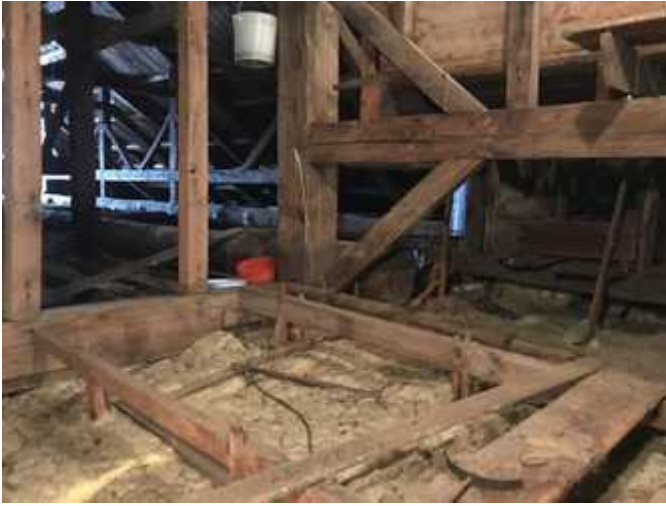
Photo 71: The Tower Frame at the Tie Beam

The original gable tie beam is discontinuous and mortise and tenons into very long 12 x 12 tower posts that terminate at the first floor level. The vertical studs to the left of the tower post still show signs of original siding and sheathing.

Note the many buckets hanging to catch rain water.

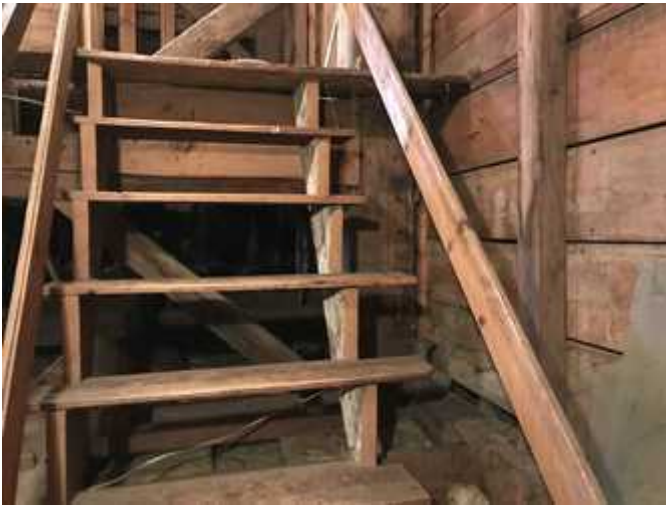
Photo 72: Access Stairs

Non-code compliant stairs provide access to the tower from the balcony.

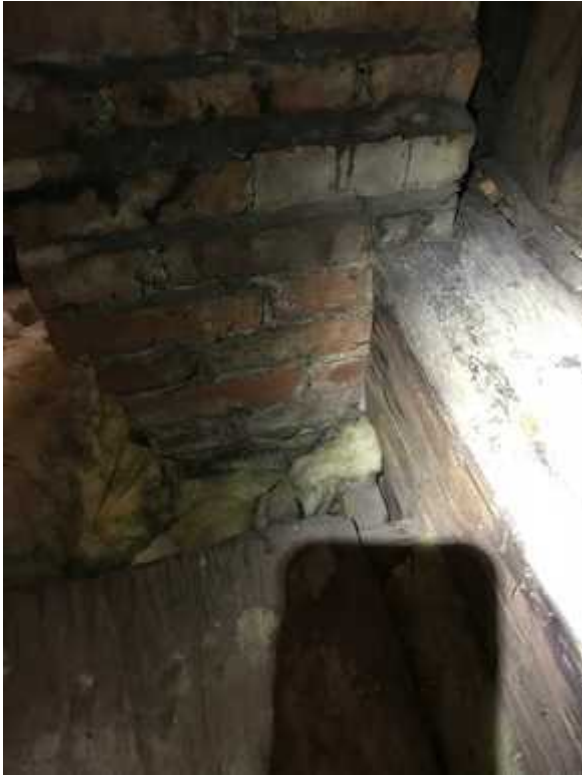
Photo 81: The Chimney

A close up of the chimney as it corbels around the gable end tie beam. While not up to code in any way, it appears to be performing as designed.

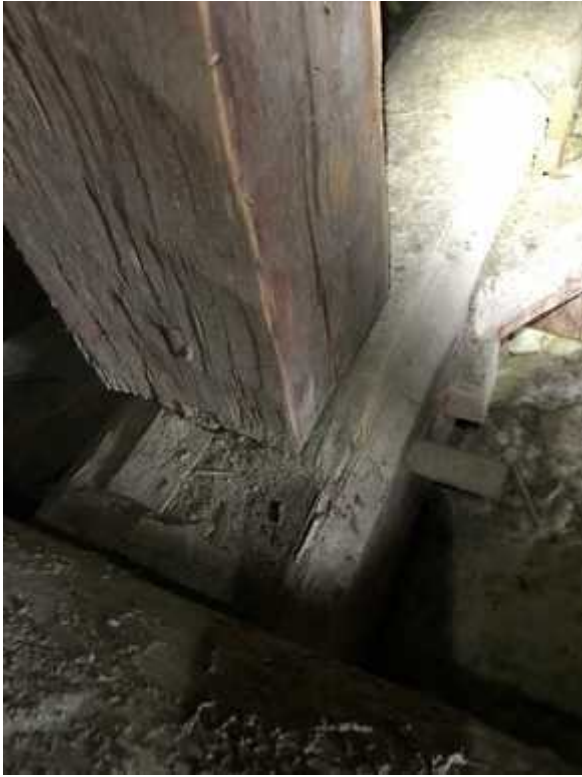
Photo 91: The Queen Post

This close up of the bottom of the queen post indicates a dovetailed through mortise in the bottom chord. With the dove tail form, the mortise is widened to accept the dove tail and once inserted into the bottom chord it is forced to one side of the mortise and plugged with a hardwood wedge (in foreground). A large pin also secures the joinery. This is a tension connection for the truss and is performing very well.

Note the angled brace top right as it mortises into the side of the bottom chord. It too has a strong hard wood wedge forcing it into place.

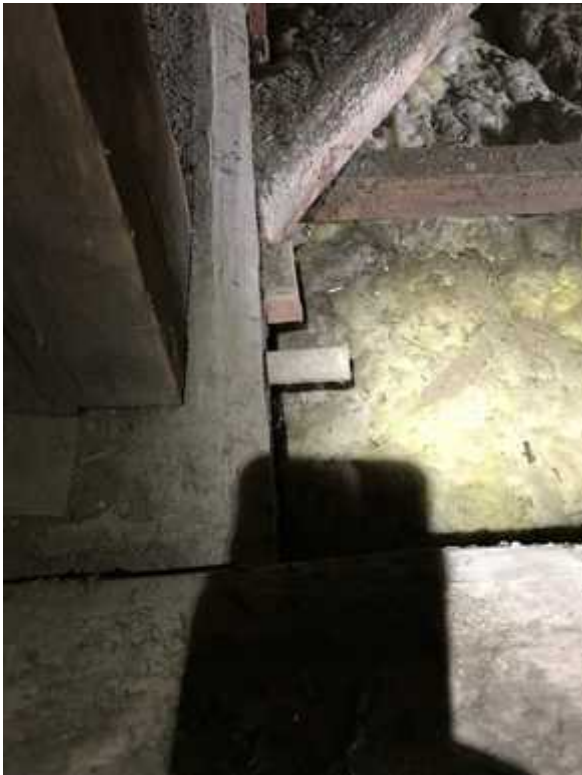
Photo 92: The Queen Post

This is a clearer view of the pin securing the queen post to the bottom chord and the wedged brace.

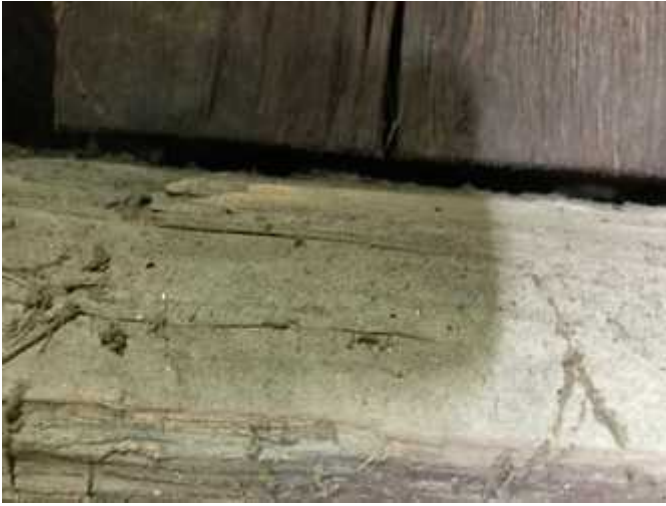
Photo 93: Queen Post

This is a very close view of the bottom of the queen post where it meets the tie beam. There is some separation between the two members but it is minimal. This indicates some shrinkage in the wood and the joinery is performing as intended.

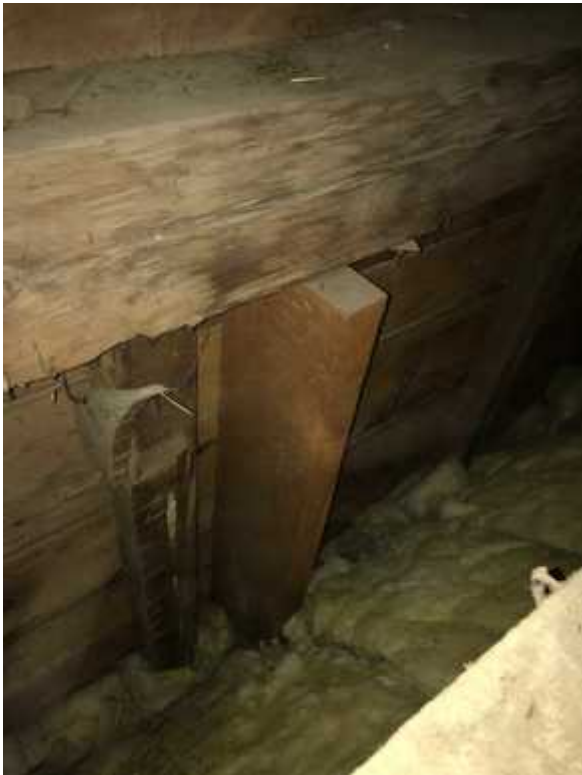
Photo 94: Eave Wall Studs

Old and newer wall studs show the evolution of the original sanctuary walls followed by the in build of the wall when new studs were placed to hide the original timber frame. The studs are deeper and wider than the top plate.

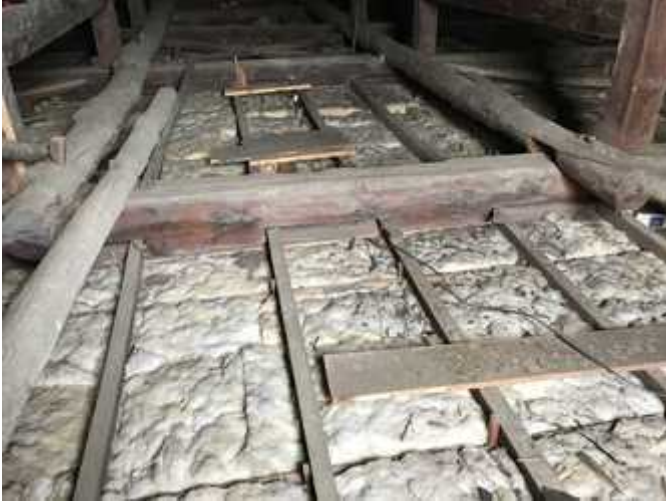
Photo 95: Attic Insulation

Ample insulation lays atop the ceiling and between ceiling joists in the attic space. It is well done and comprehensive across the sanctuary space.

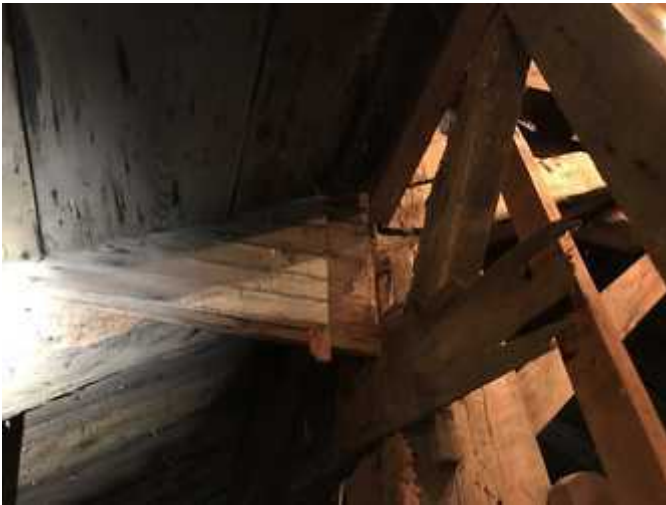
Photo 96: Original Meetinghouse Gable End

Where a roof rafter meets the tower framing one observes original sheathing and clapboards from the original exterior wall of the 18th century meetinghouse. This area is no interior to the building with the addition of two wings that encapsulate the tower.
