CHESTER CONGREGATIONAL CHURCH

PHOTO REPORT MARCH\APRIL 2018

By Arron Sturgis on March 26, 2018

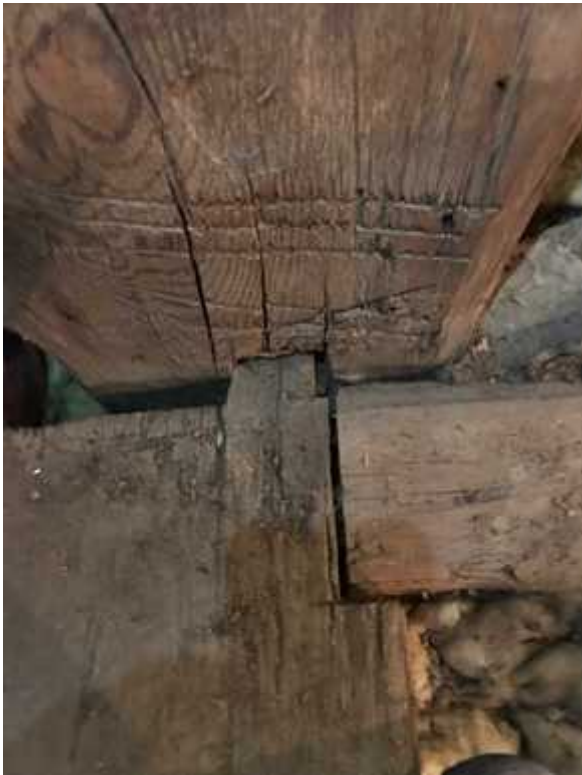
Photo 98: The Tower Frame

Top of photo is one of tower posts. It is full length from the basement of the church up through to the belfry frame. The original gable end tie beam is interrupted by the full length post. Here you can view the tenon where the tie beam engages the post.

A tower floor joist extends to the right of the picture.

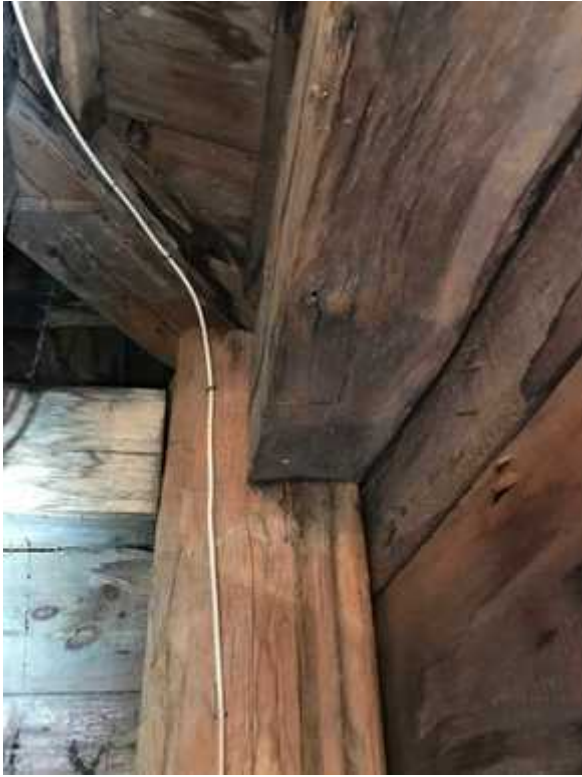
Photo 101: The Tower Box

This is the top of the tower box post. It rises from the basement to the belfry roof framing. Note that the horizontal girt is mortised into the post a few inches below the hip roof framing of the belfry roof. This indicates that the posts were once taller but now cut down for a new belfry and spire form.

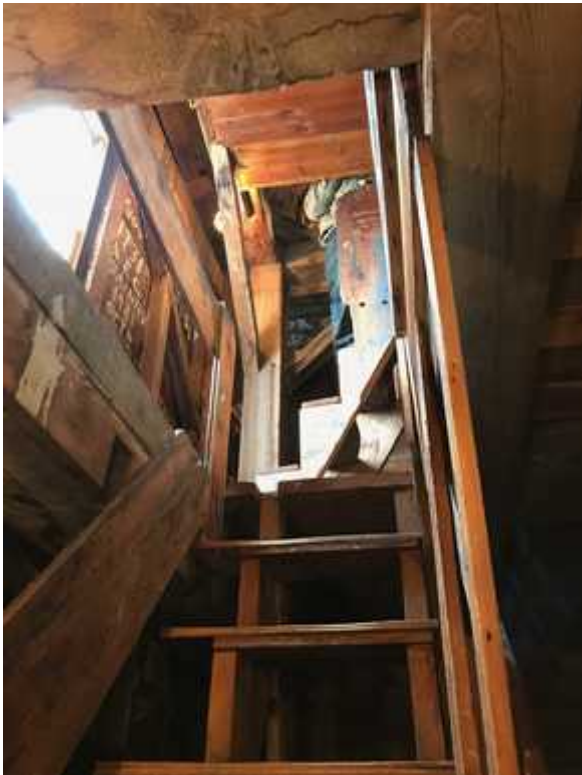
Photo 102: Tower Stairs and Belfry Framing

The four sided belfry framing passes down through the interior of the tower box frame onto bed timbers below. The stairs ascend to a hatch accessing the bell and bell roof. Angled braces reinforce the belfry frame and with the overlap of the two frames, the tower is very strong and resistant to wind.

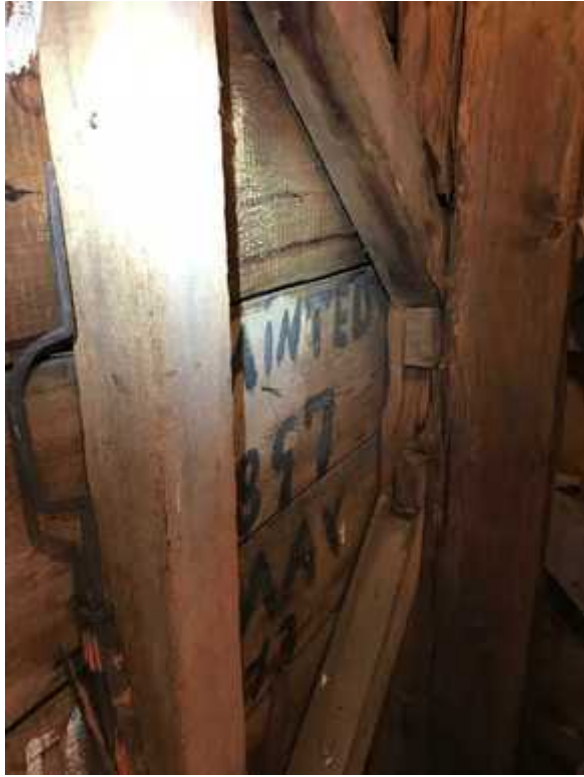
Photo 103: Belfry Frame

The belfry frame is very strong. Ascending and descending braces stiffen the frame. The wedges driven into the wide brace mortises allow the frame to be stood up one post at a time inside the tower box frame and with the braces added later and then wedged tight.

Horizontal sheathing with graffiti protects the clock room.

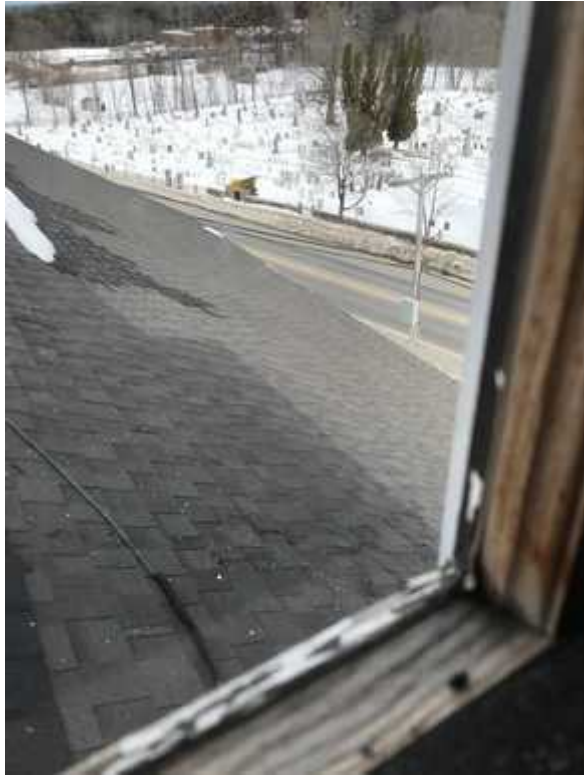
Photo 105: Roof Covering

Architectural shingles hold some snow after a storm but wind also takes the majority of snow from the roof.

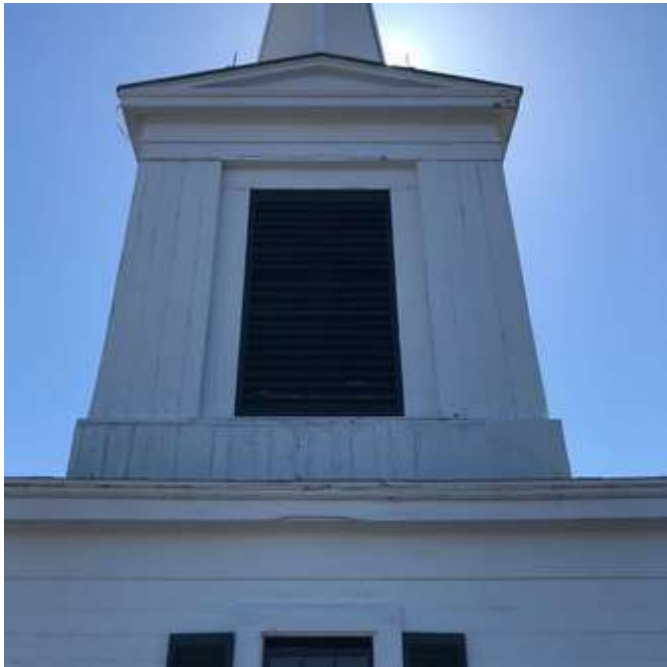
Photo 106: Northeast Facade, Belfry Tower

Northeast facade of the tower. Vertical flush board siding provides a Greek Revival look for the steeple.

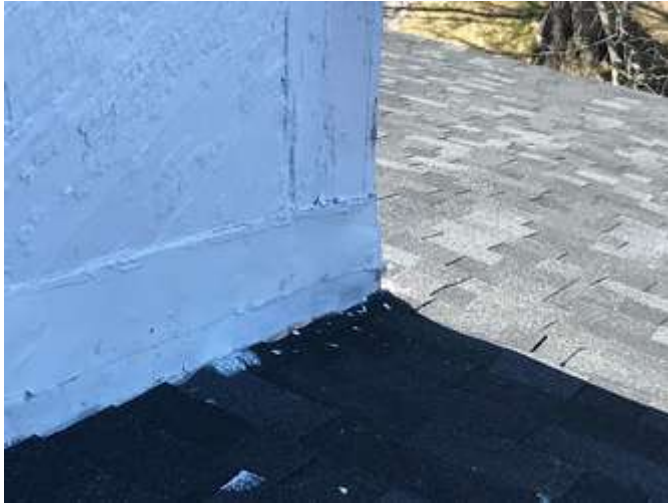
Photo 107: Belfry interface with Asphalt Roof

Step flashing from the new roof is painted and tucks under the face flashing. This does not keep water out of the roof.

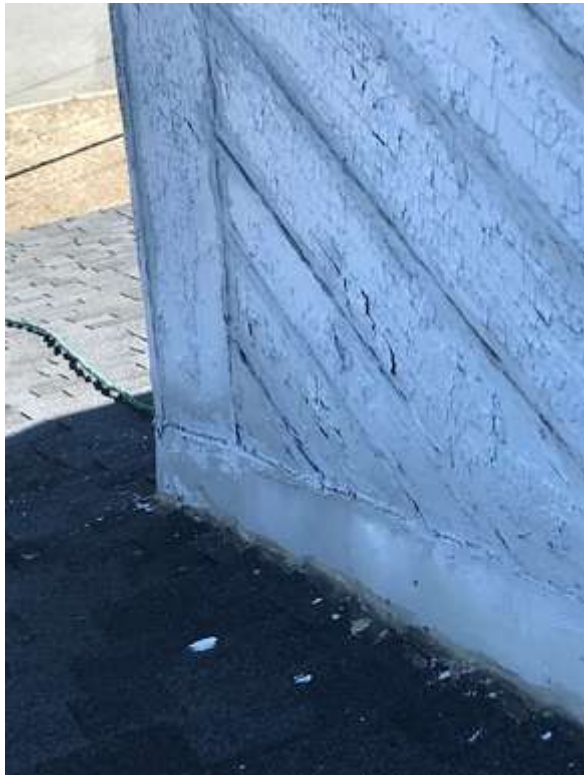
Photo 108: Face Flashing and Lead Paint on Flush Siding of Belfry

Poorly installed face flashing over flush board siding is letting water into to the interior of the church. Siding is coated with years of lead paint and must be abated.

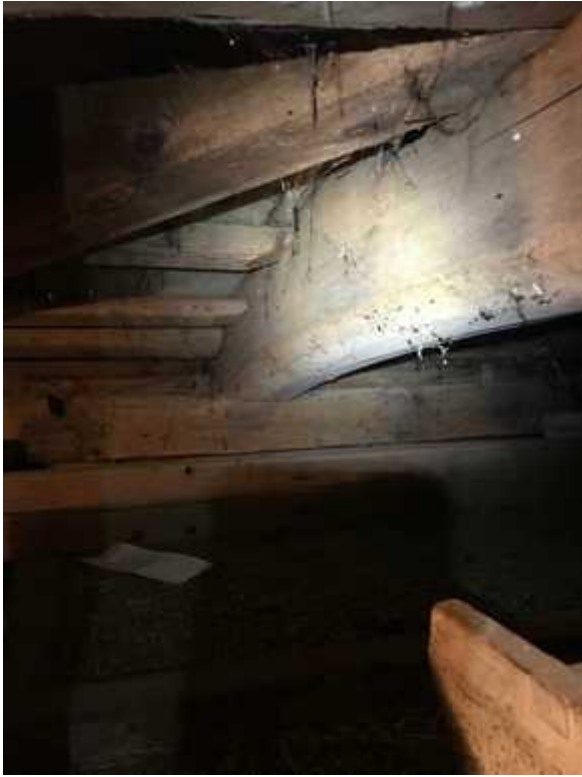
Photo 109: Bell Roof

The bell roof is one of the strongest framed roof systems we have ever seen. It is created with a hewn camber on top and bottom planes of a heavy center beam. Horizontal purlins span between this primary roof beam to hip rafters making a shallow hipped roof that is really strong and supportive of the bell and bell cradle above.

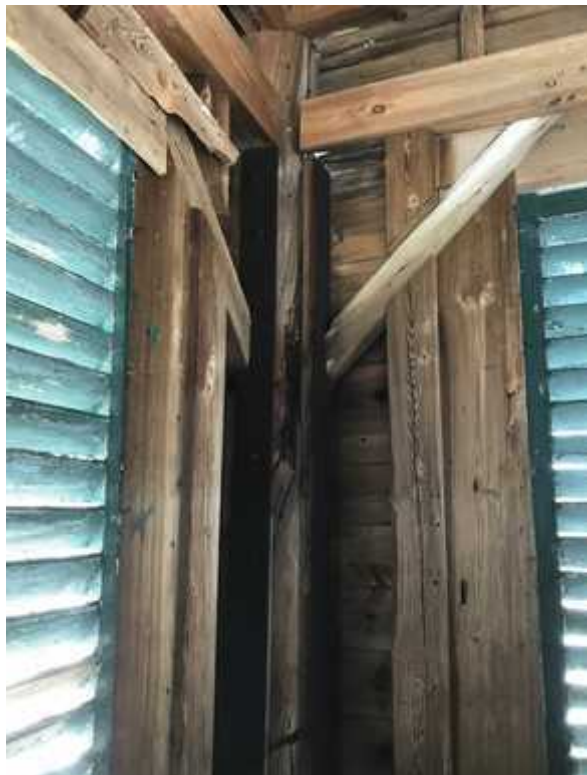
Photo 114: Belfry Posts

The West corner post of the belfry is completely rotten.

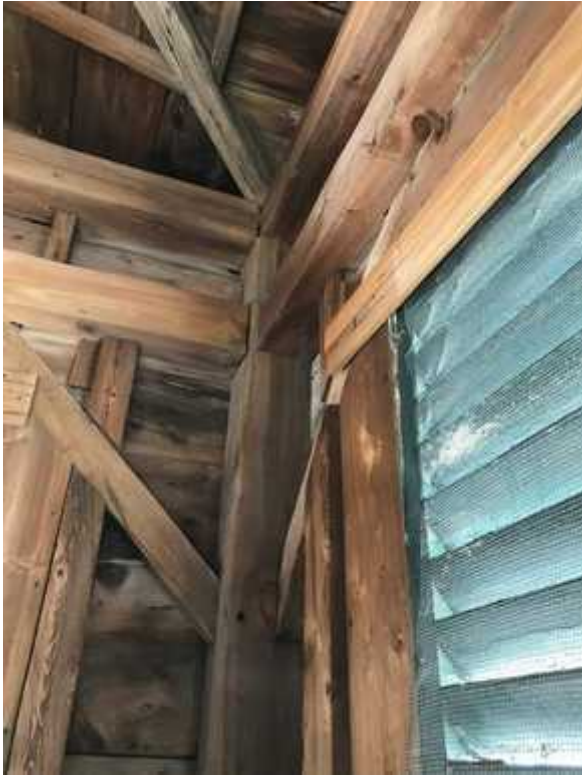
Photo 117: Belfry Tower Frame

The belfry frame joinery is completely square ruled and this indicates that it is later than the original tower box frame below. This is in keeping with historical evidence documented over time.

Large louvers are placed near center of each belfry wall face. Small studs infill the belfry walls to support the louvers.

Angled braces ascend from the post to the spire girt to stiffen the frame and support the weight of the spire frame above.

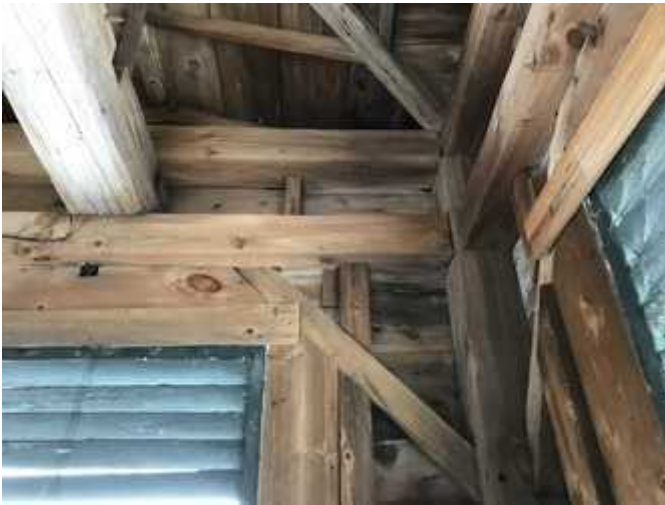
Photo 118: Belfry and Spire Frames

The belfry and spire frames have some overlap and redundancy but it is limited because of the bell cradle and bell below.

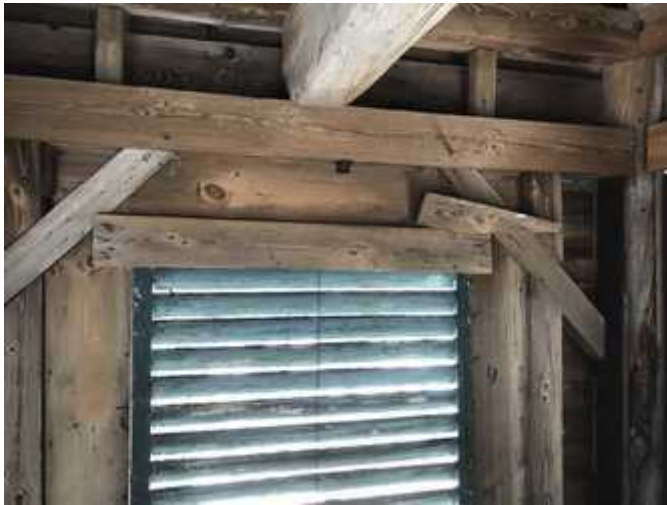
Photo 120: Spire Base Frame

The ends of the spire base frame is through bolted into the spire girt just below the belfry top plate.

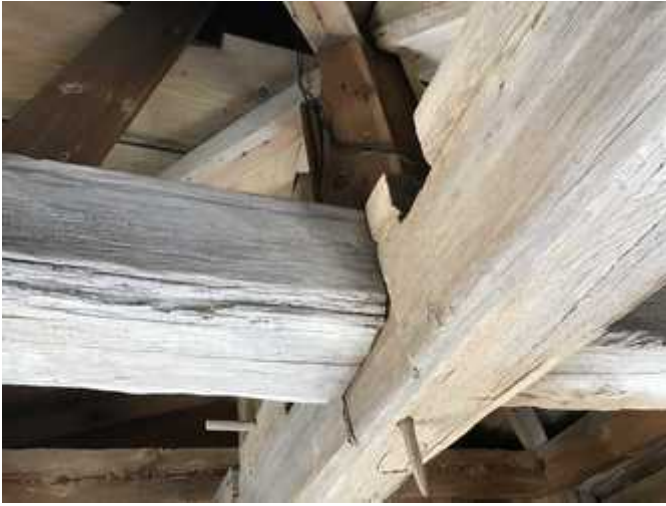
Photo 121: Spire Base Frame

Two belfry spire base frame beams cross 90 degrees to each other and cog over each other at center of belfry. A small mast rises from the apex of the crossed beams and supports the small hip rafters of the spire base roof.

An angled strut also ascends from the left side of the picture to a center spire mast to stiffen the mast and it runs parallel to the spire rafter.

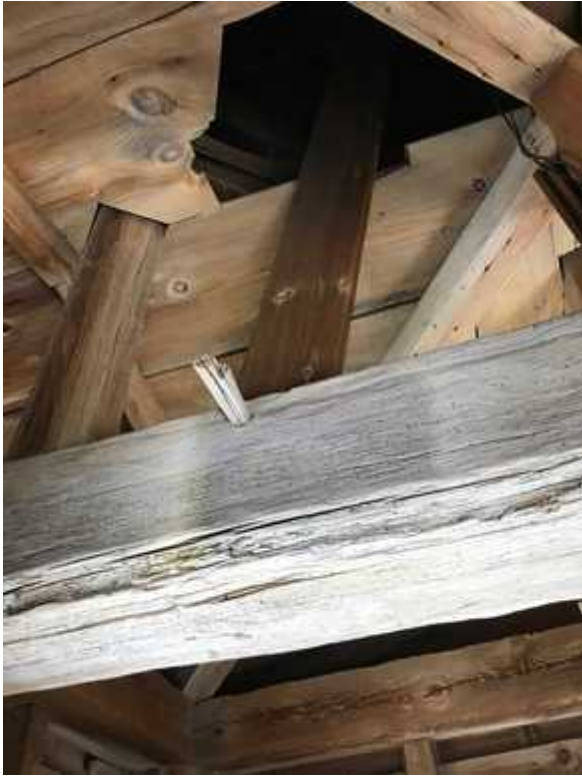
Photo 123: Spire Base Frame

Sheathing for the spire base roof closes in around the spire rafters and spire struts. A pin secures a mortise and tenon joint on top of the spire base for each spire rafter and strut.

This sheathing stiffens the spire base roof but obscures the upper levels of the spire.

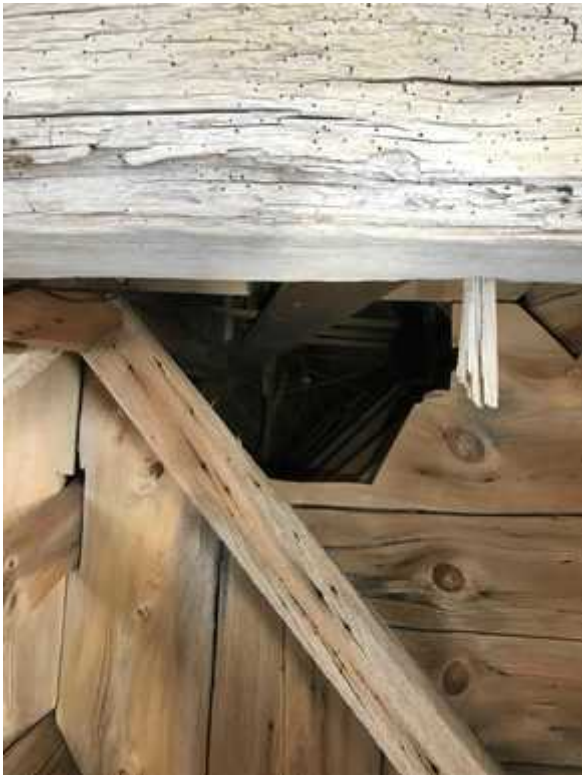
Photo 124: Spire

Looking up through the spire you can see that each spire rafter is connected by multiple nailed in tiny horizontal cross bracing. This allows for exterior sheathing to be nailed vertically up the length of the spire.

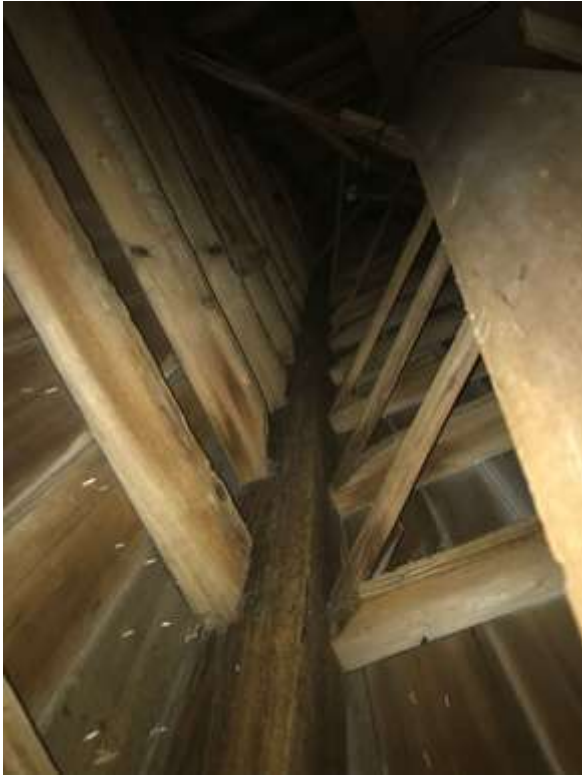
Photo 125: Spire Internal Framing

Looking up into the spire one views the principal spire rafter connected with horizontal dimensional two by four purlins with vertical tongue and groove sheathing. Clapboards protect the spire from the exterior.

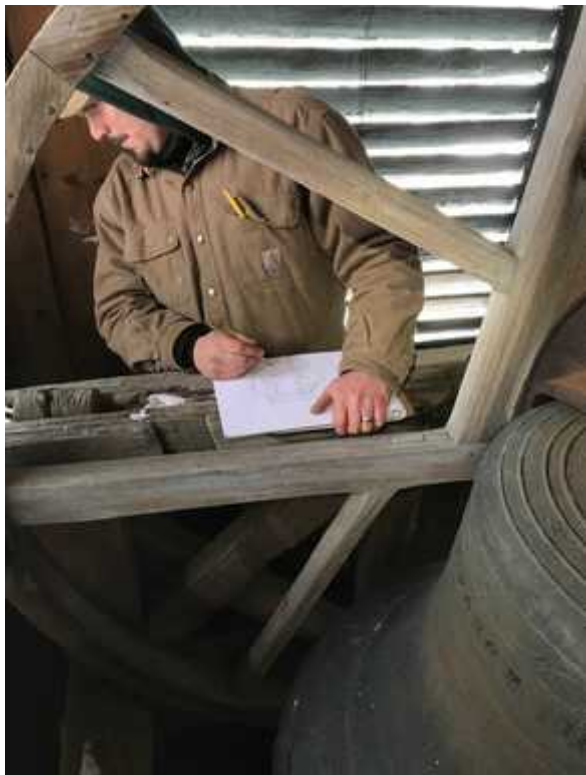
Photo 132: Bell Wheel

Dave provides scale for the size of the bell wheel. The wheel is created with beautiful through mortises and the members wonderfully beveled along their edges. The bell guide boards appear to be replacements.

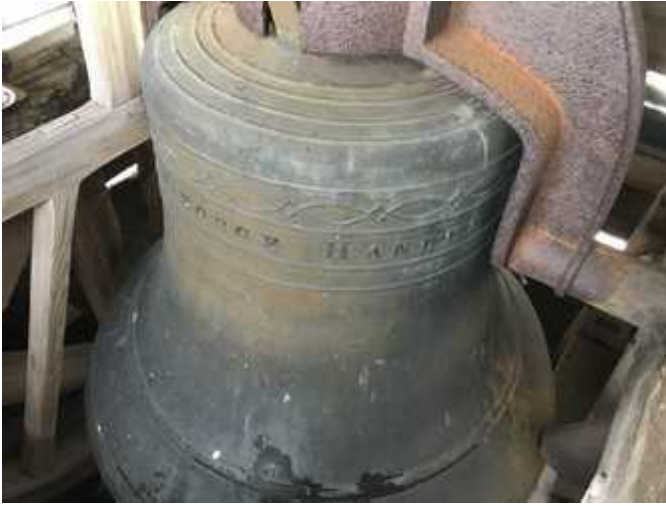
Photo 133: The Bell

The cast bell is mounted to a steel yoke supported by the early bell cradle.

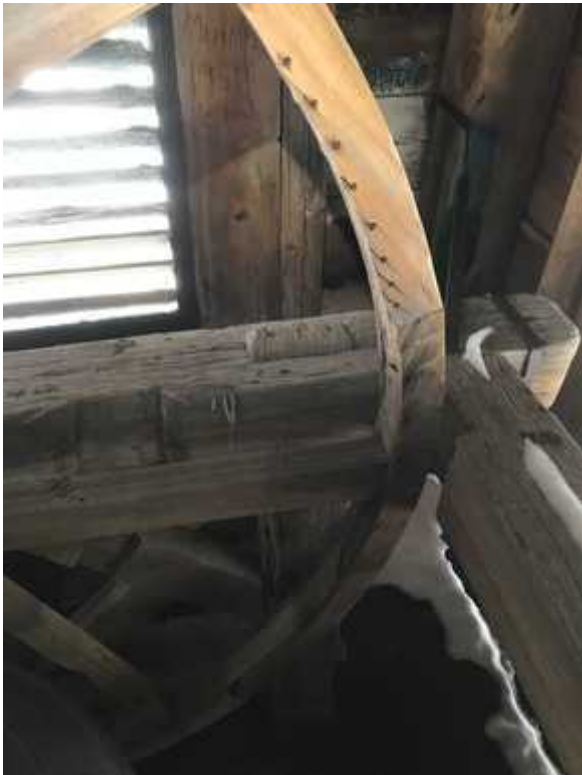
Photo 134: Bell Cradle

The old bell cradle hosts through mortises for extra strength. Steel straps connect the cradle to the four belfry posts at the corners.

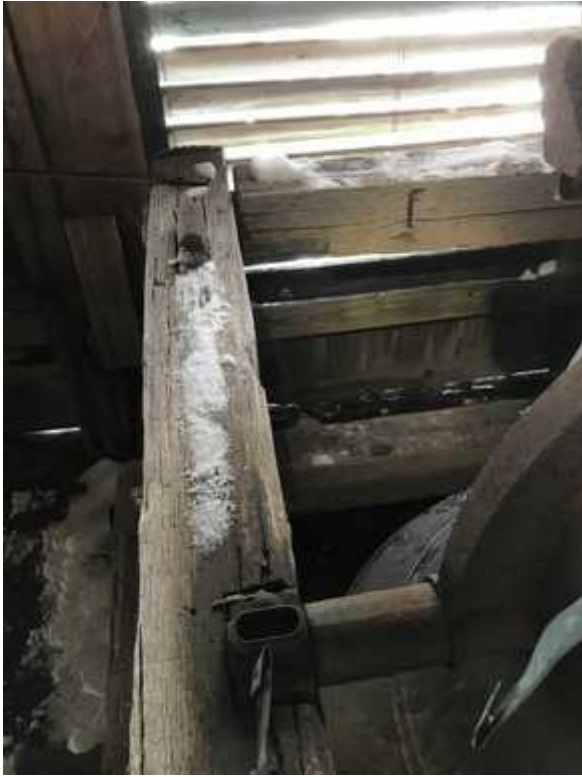
Photo 135: Bell Cradle

The bell yoke appears to simply sit with gravity into a pocket within the bell cradle top plate.

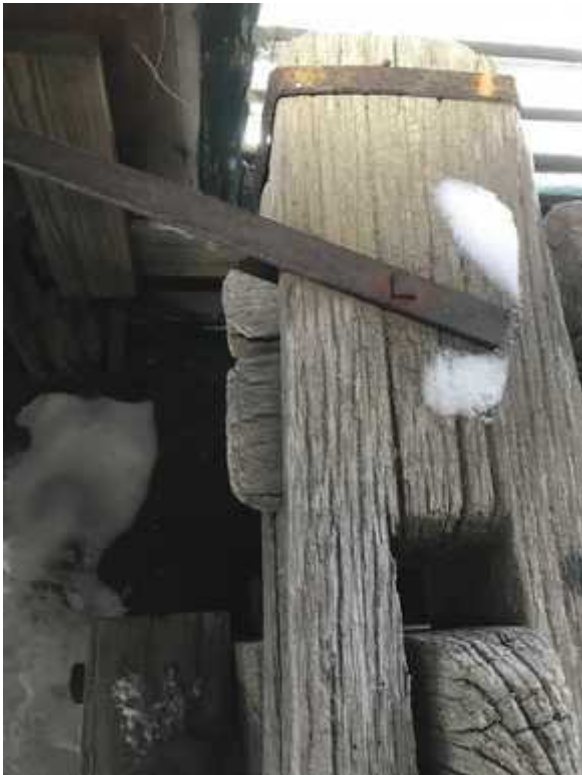
Photo 136: Bell Cradle

Angled steel straps connect cradle with belfry posts. A steel strap reinforces the joinery of the cradle.

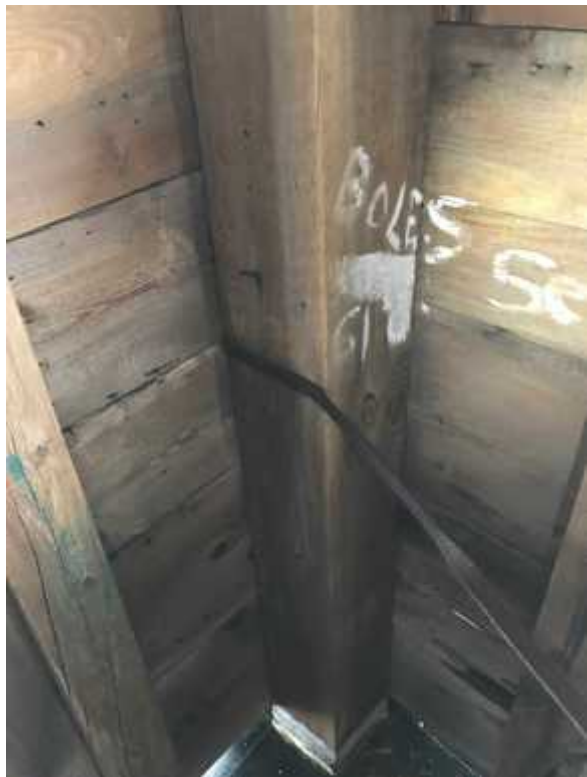
Photo 137: Bell Cradle

A steel strap connects the bell cradle to the belfry posts at each corner.

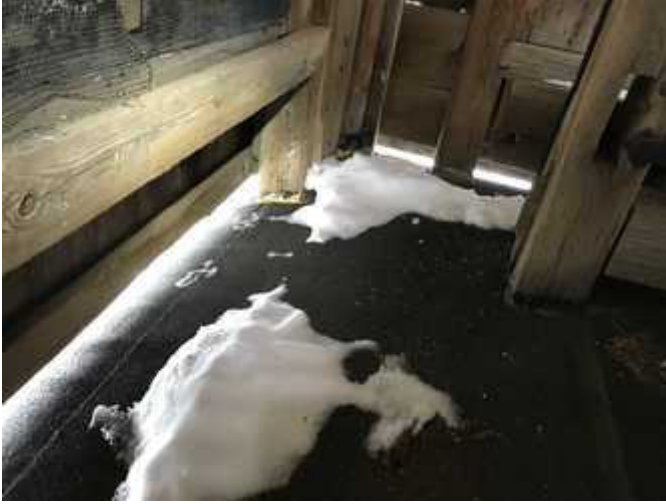
Photo 139: Belfry Roof

Rolled roofing covers the belfry hip roof. It is very difficult to keep this roof from leaking. The rolled roofing turns up the belfry post and is nailed on the face of the post. This provides no counter flashing and invites water to the belfry interior.

Caulking and tar attempt to make the roof tight with little success.

The belfry roof has to accommodate the penetrations of the belfry posts. The louvers and belfry siding protect this area from direct rain and snow, but the base of the louver lets snow blow in and build up inside the bell level. This roof is not ideal.

The belfry roof has very little room to move around. The bell cradle must be lifted off the roof along with the bell to correctly repair the belfry roof. The roof would be replaced with copper from outside staging to access this level of the steeple.

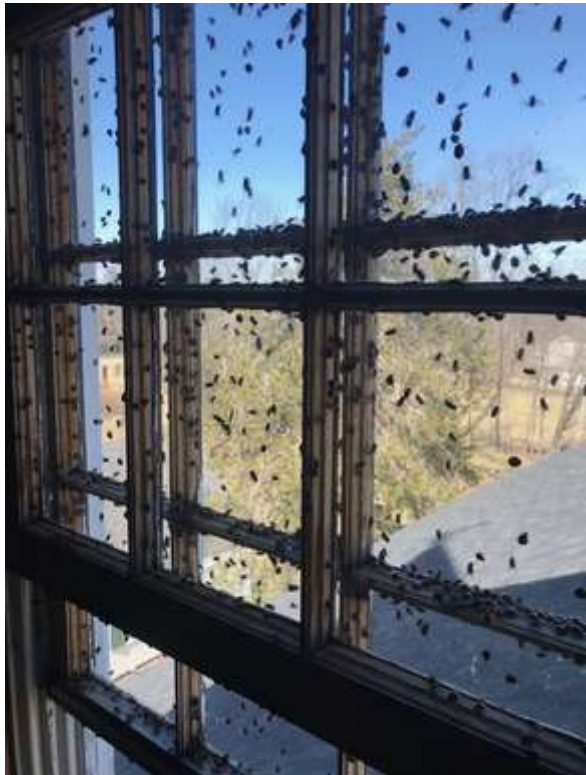
Photo 142: Steeples have residents

A vast ladybug and fly bloom in late April on the tower box window.
